# Technical Memo

Project: US14A / US85 Deadwood Box Corridor Study

Subject: Existing Conditions **DRAFT**

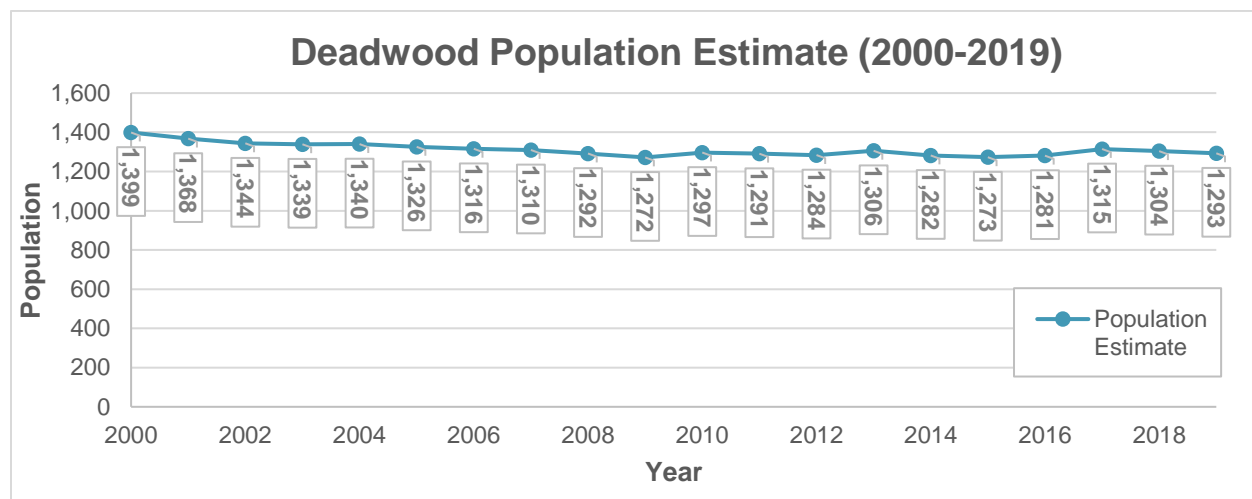
Figure 2. Deadwood 20-Year Population Trend

During its heyday of the gold-rush, the city was home to a population of 25,000. According to the most recent 2010 US census, the current population of Deadwood is 1,270. Although Deadwood has undergone several boom and busts due to its mining history, the population has remained relatively stable the last 20 years. As shown in Figure 2, the population was slowly declining between years 2000 to 2008 and has leveled out in the last 10 years. The Homestake Mine located in nearby City of Lead, the largest and deepest gold mine in the US, may be the cause of the slow decline in population for the years following its closure in 2001. The Homestake Mine later had a revival in 2006 when it was converted into the Sanford Underground Research Facility, bringing employees and more economic activity to the Lead-Deadwood area (City of Deadwood, 2018)<sup>2</sup>. The data collection efforts of the 2020 census are still underway and are not included in the population estimate graph.

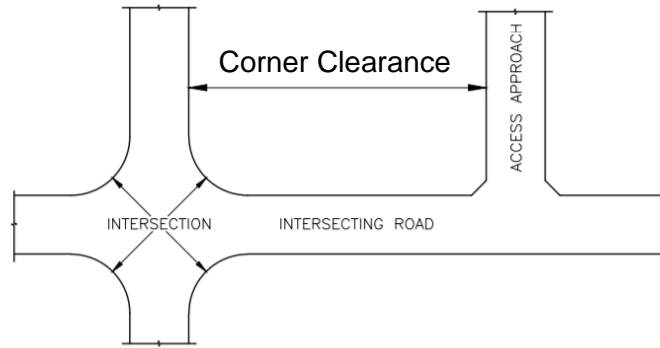
**Figure 6. Corner Clearance Illustration**

The following table summarizes the access spacing and density criteria applicable to US14A / Pioneer Way and US85. This criteria is used as a guide to establish locations for further analysis and opportunities to implement retrofit techniques to improve access as part of the future Deadwood Box project. Figure 6 illustrates how corner clearance is measured from a main intersection to an access.

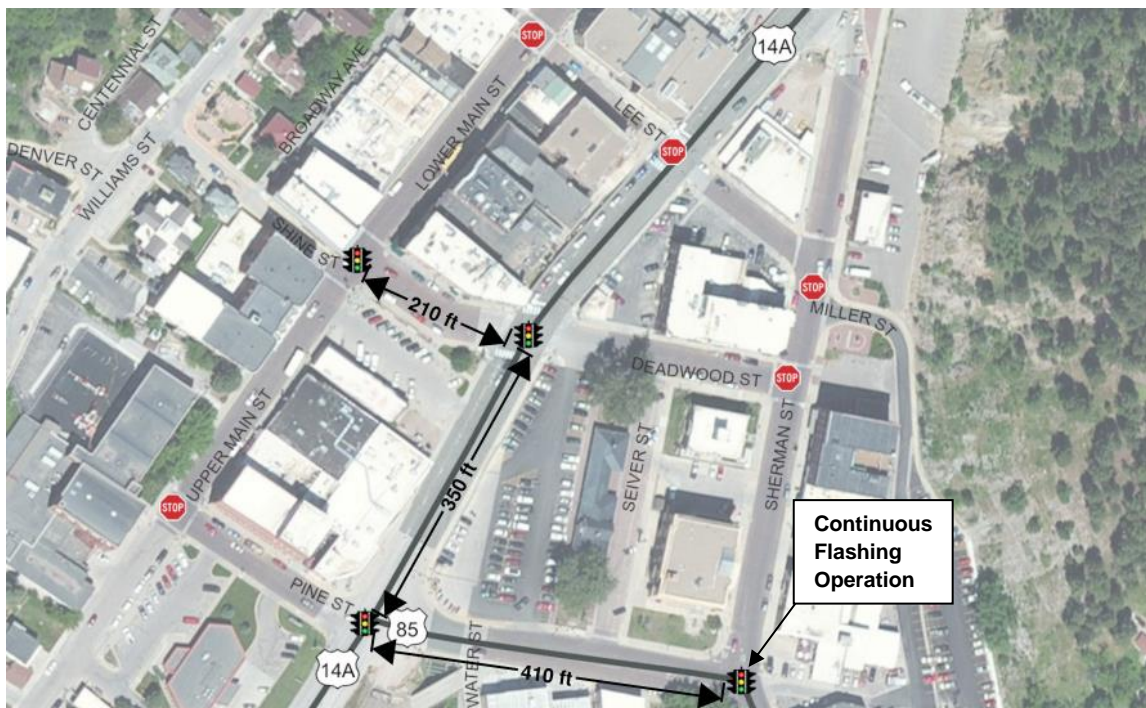
**Figure 7. Spacing of Signals in Deadwood's Downtown Core**

The proximity of four intersections within Deadwood's downtown core is shown in Figure 7. Figure 8 displays the all signalized intersections in the study area and whether the signalized intersections meet the spacing criteria listed in Table 1. Based on a signal spacing distance of one-quarter of a mile or 1320 feet, only one of the signalized intersections within the Study Area, the intersection of US14A and the northern junction with US85, meets the signal spacing distance criteria. The main reason for the closely spaced signalized intersections within the study area is due to limited space, the condensed nature of the Deadwood area, and the proximity of three parallel or somewhat parallel arterial corridors including Main Street (minor arterial), US14A / Pioneer Way (principal arterial), and Sherman Street (minor arterial). Historically, signals have been implemented in central business districts (CBD) to manage mobility and provide signalized pedestrian crossings. The signal density within Deadwood's downtown core isn't out of the norm for a downtown/CBD.

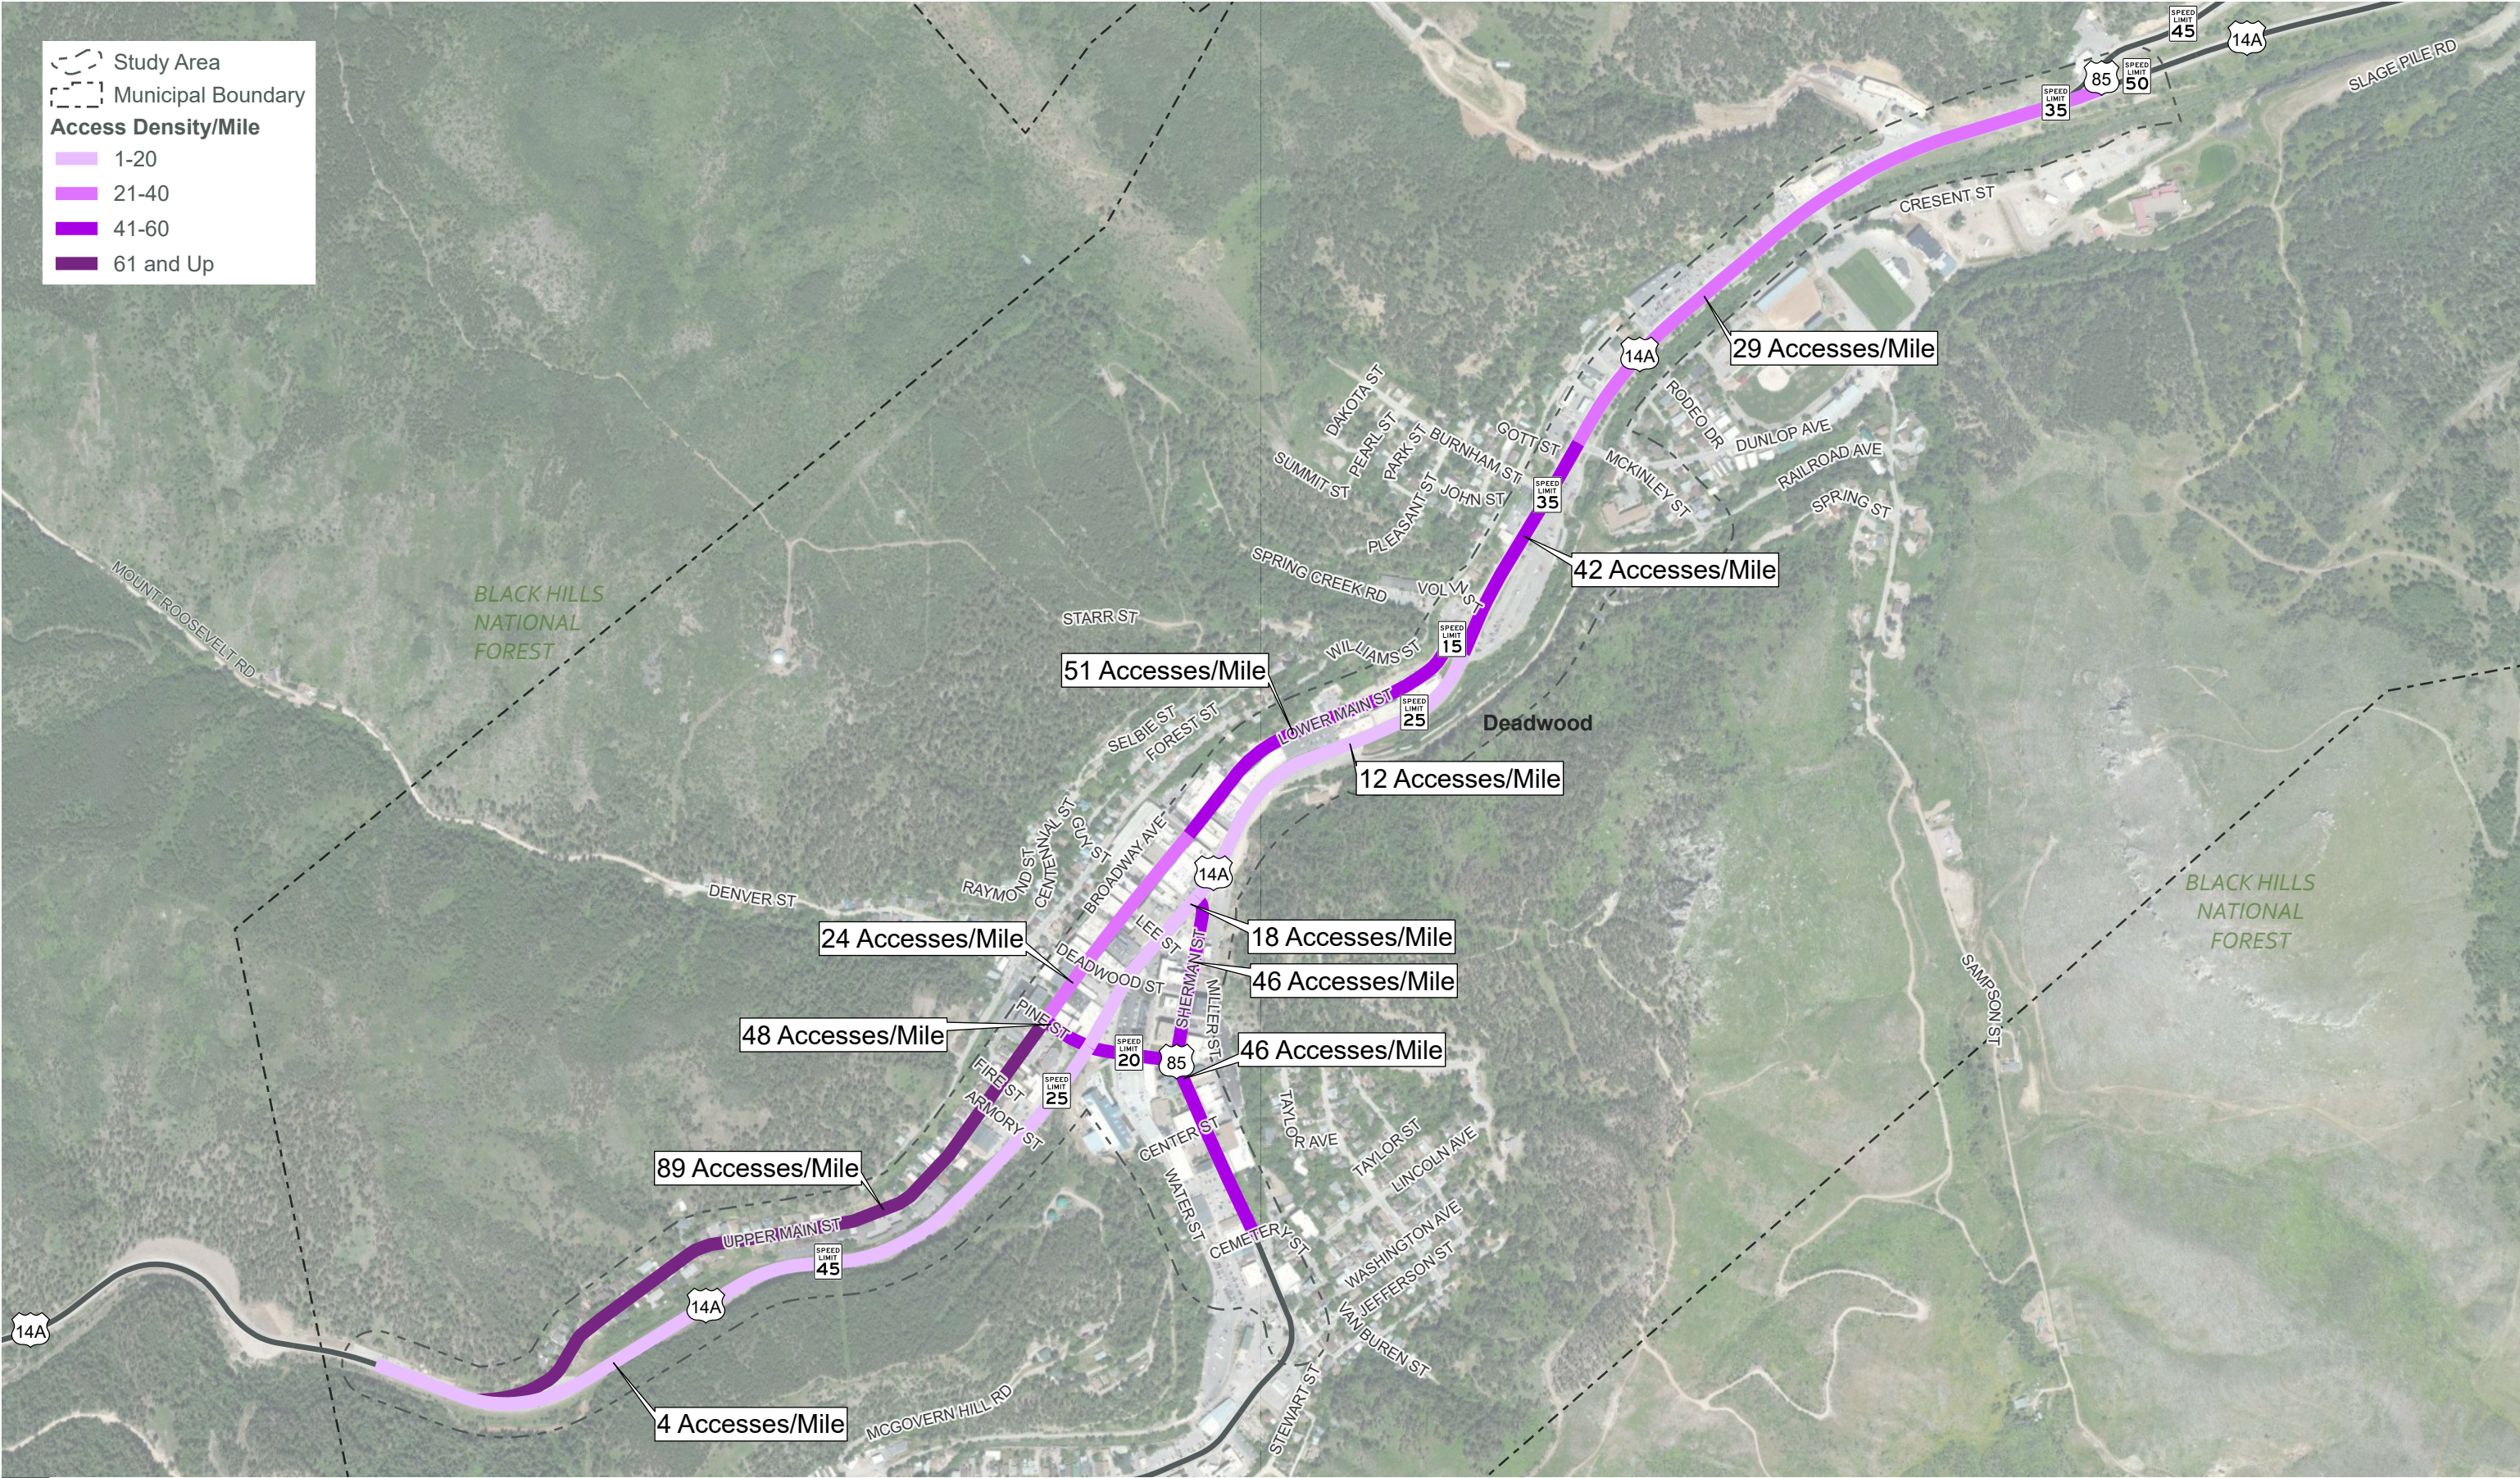
**ACCESS DENSITY**  
**FIGURE 9**

Figure 9 breaks the corridors down into smaller segments and shows the access density in accesses per mile. The highest access density can be found along the residential portion of Upper Main Street, US85 / Sherman Street, US85 / Pine Street, and Lower Main Street. US14A / Pioneer Way, north of Lower Main Street, has a fairly high access density as well.

High access density is prevalent throughout the main study area corridors and there may be an opportunity to consolidate accesses along US14A to the north of Lower Main Street. Only one of the signalized intersections within the study area meet the minimum SDDOT signal spacing criteria, but this is the norm for CBDs. This study will recommend retrofit techniques to improve access in consideration of desired access and mobility within the study area.

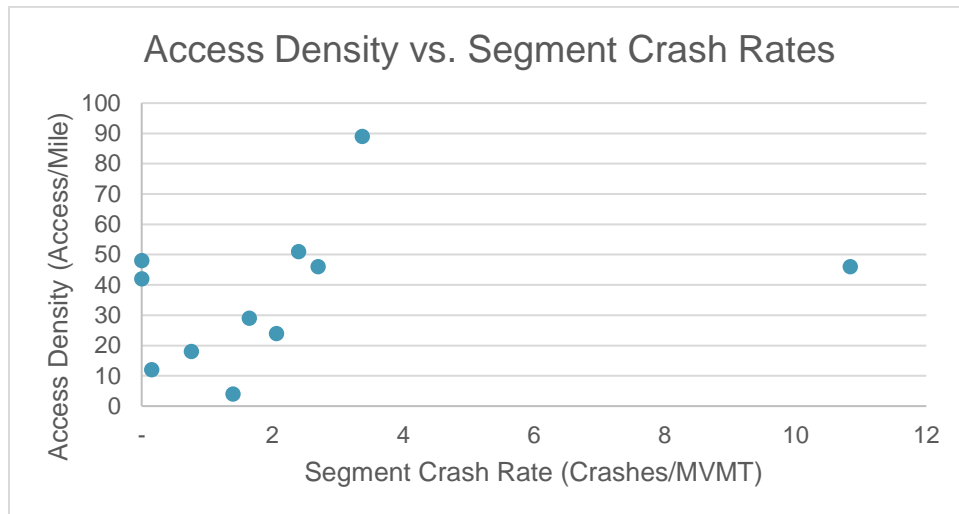
Figure 10. Scatter Plot of Access Density vs. Segment Crash Rates

A scatter plot graph, shown in Figure 10, compares the access density measured in accesses per mile to each segment's respective crash rate measured in crashes per million vehicle miles traveled (MVMT). Recognizing that there are outliers and several other factors that influence crash rates, this graph does support a correlation that more accesses may result in more crashes while taking into account segment length and exposure. The *Crash History Review Memo*, provides further detail on segment crash rates.

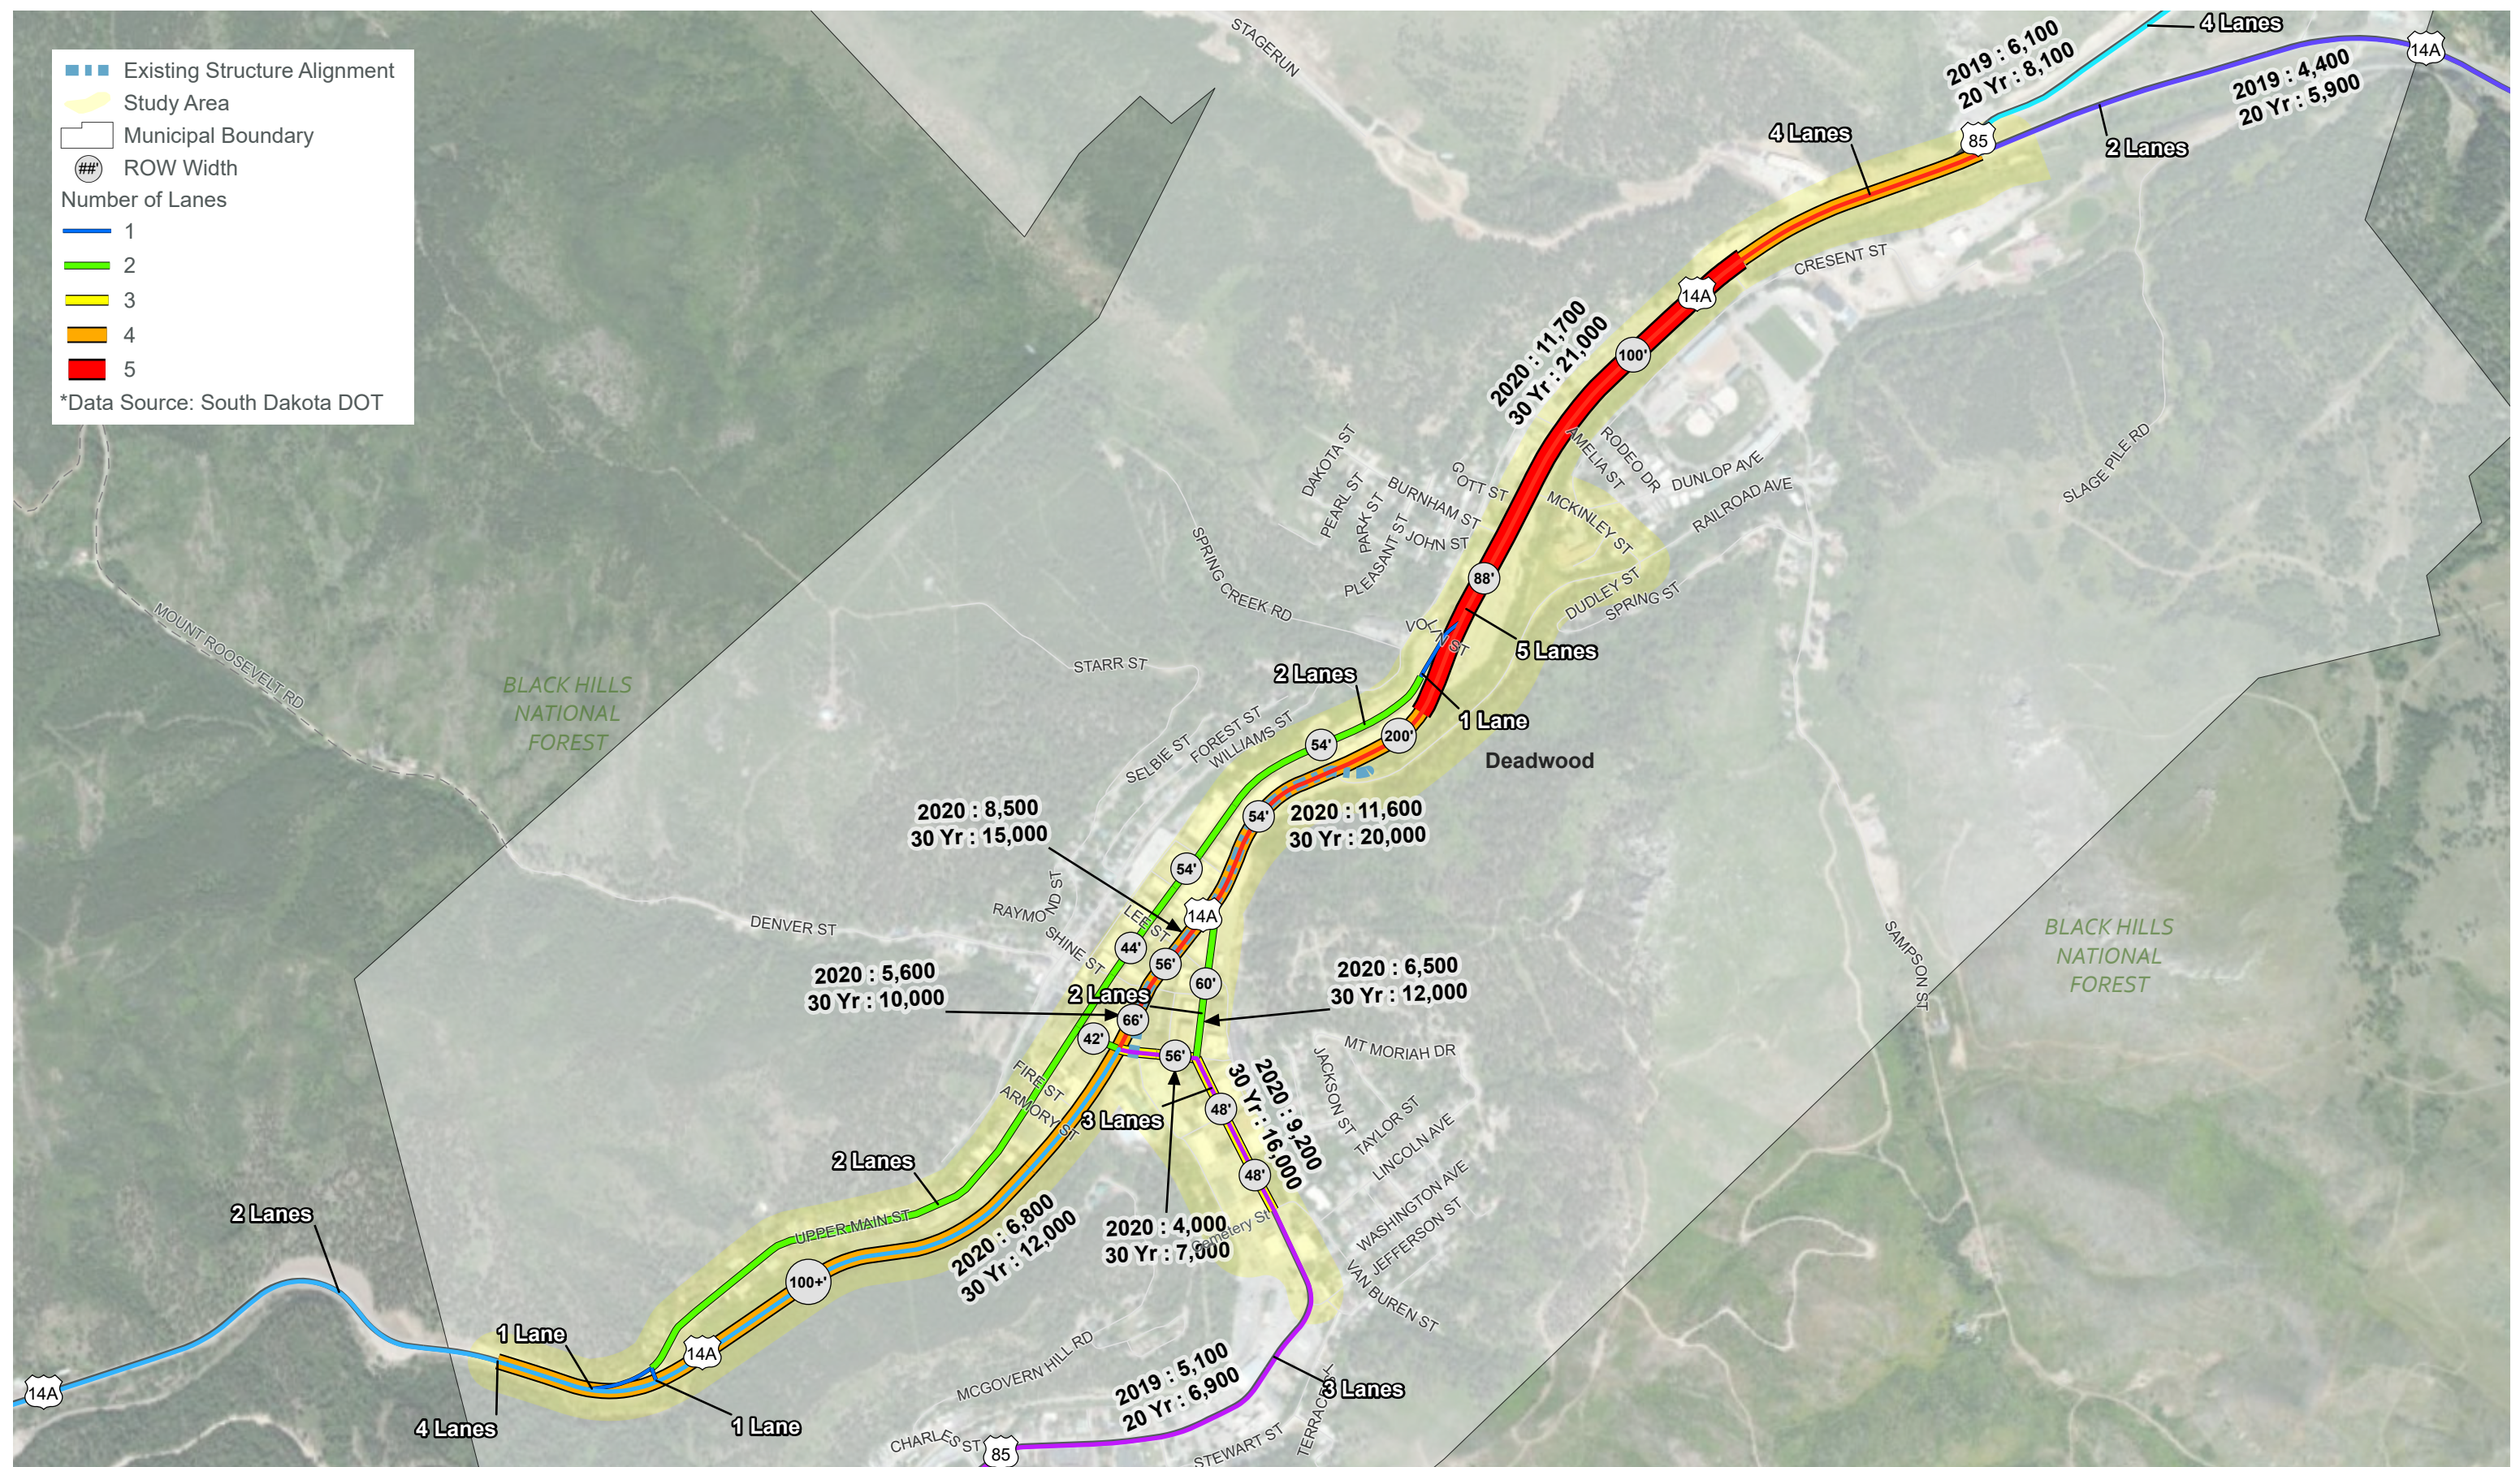
As shown on Figure 12, Deadwood has a mixture of brick pavers, asphalt, and concrete as roadway surfacing. Brick pavers are prevalent throughout Deadwood to enhance the historic feel of the City. Brick is used on Main Street from Pine Street to Wall Street, Sherman Street from US14A to Cemetery Street, and the total length of Pine Street and some side streets within the study area. The remainder of the study area is paved with concrete or bituminous pavement.

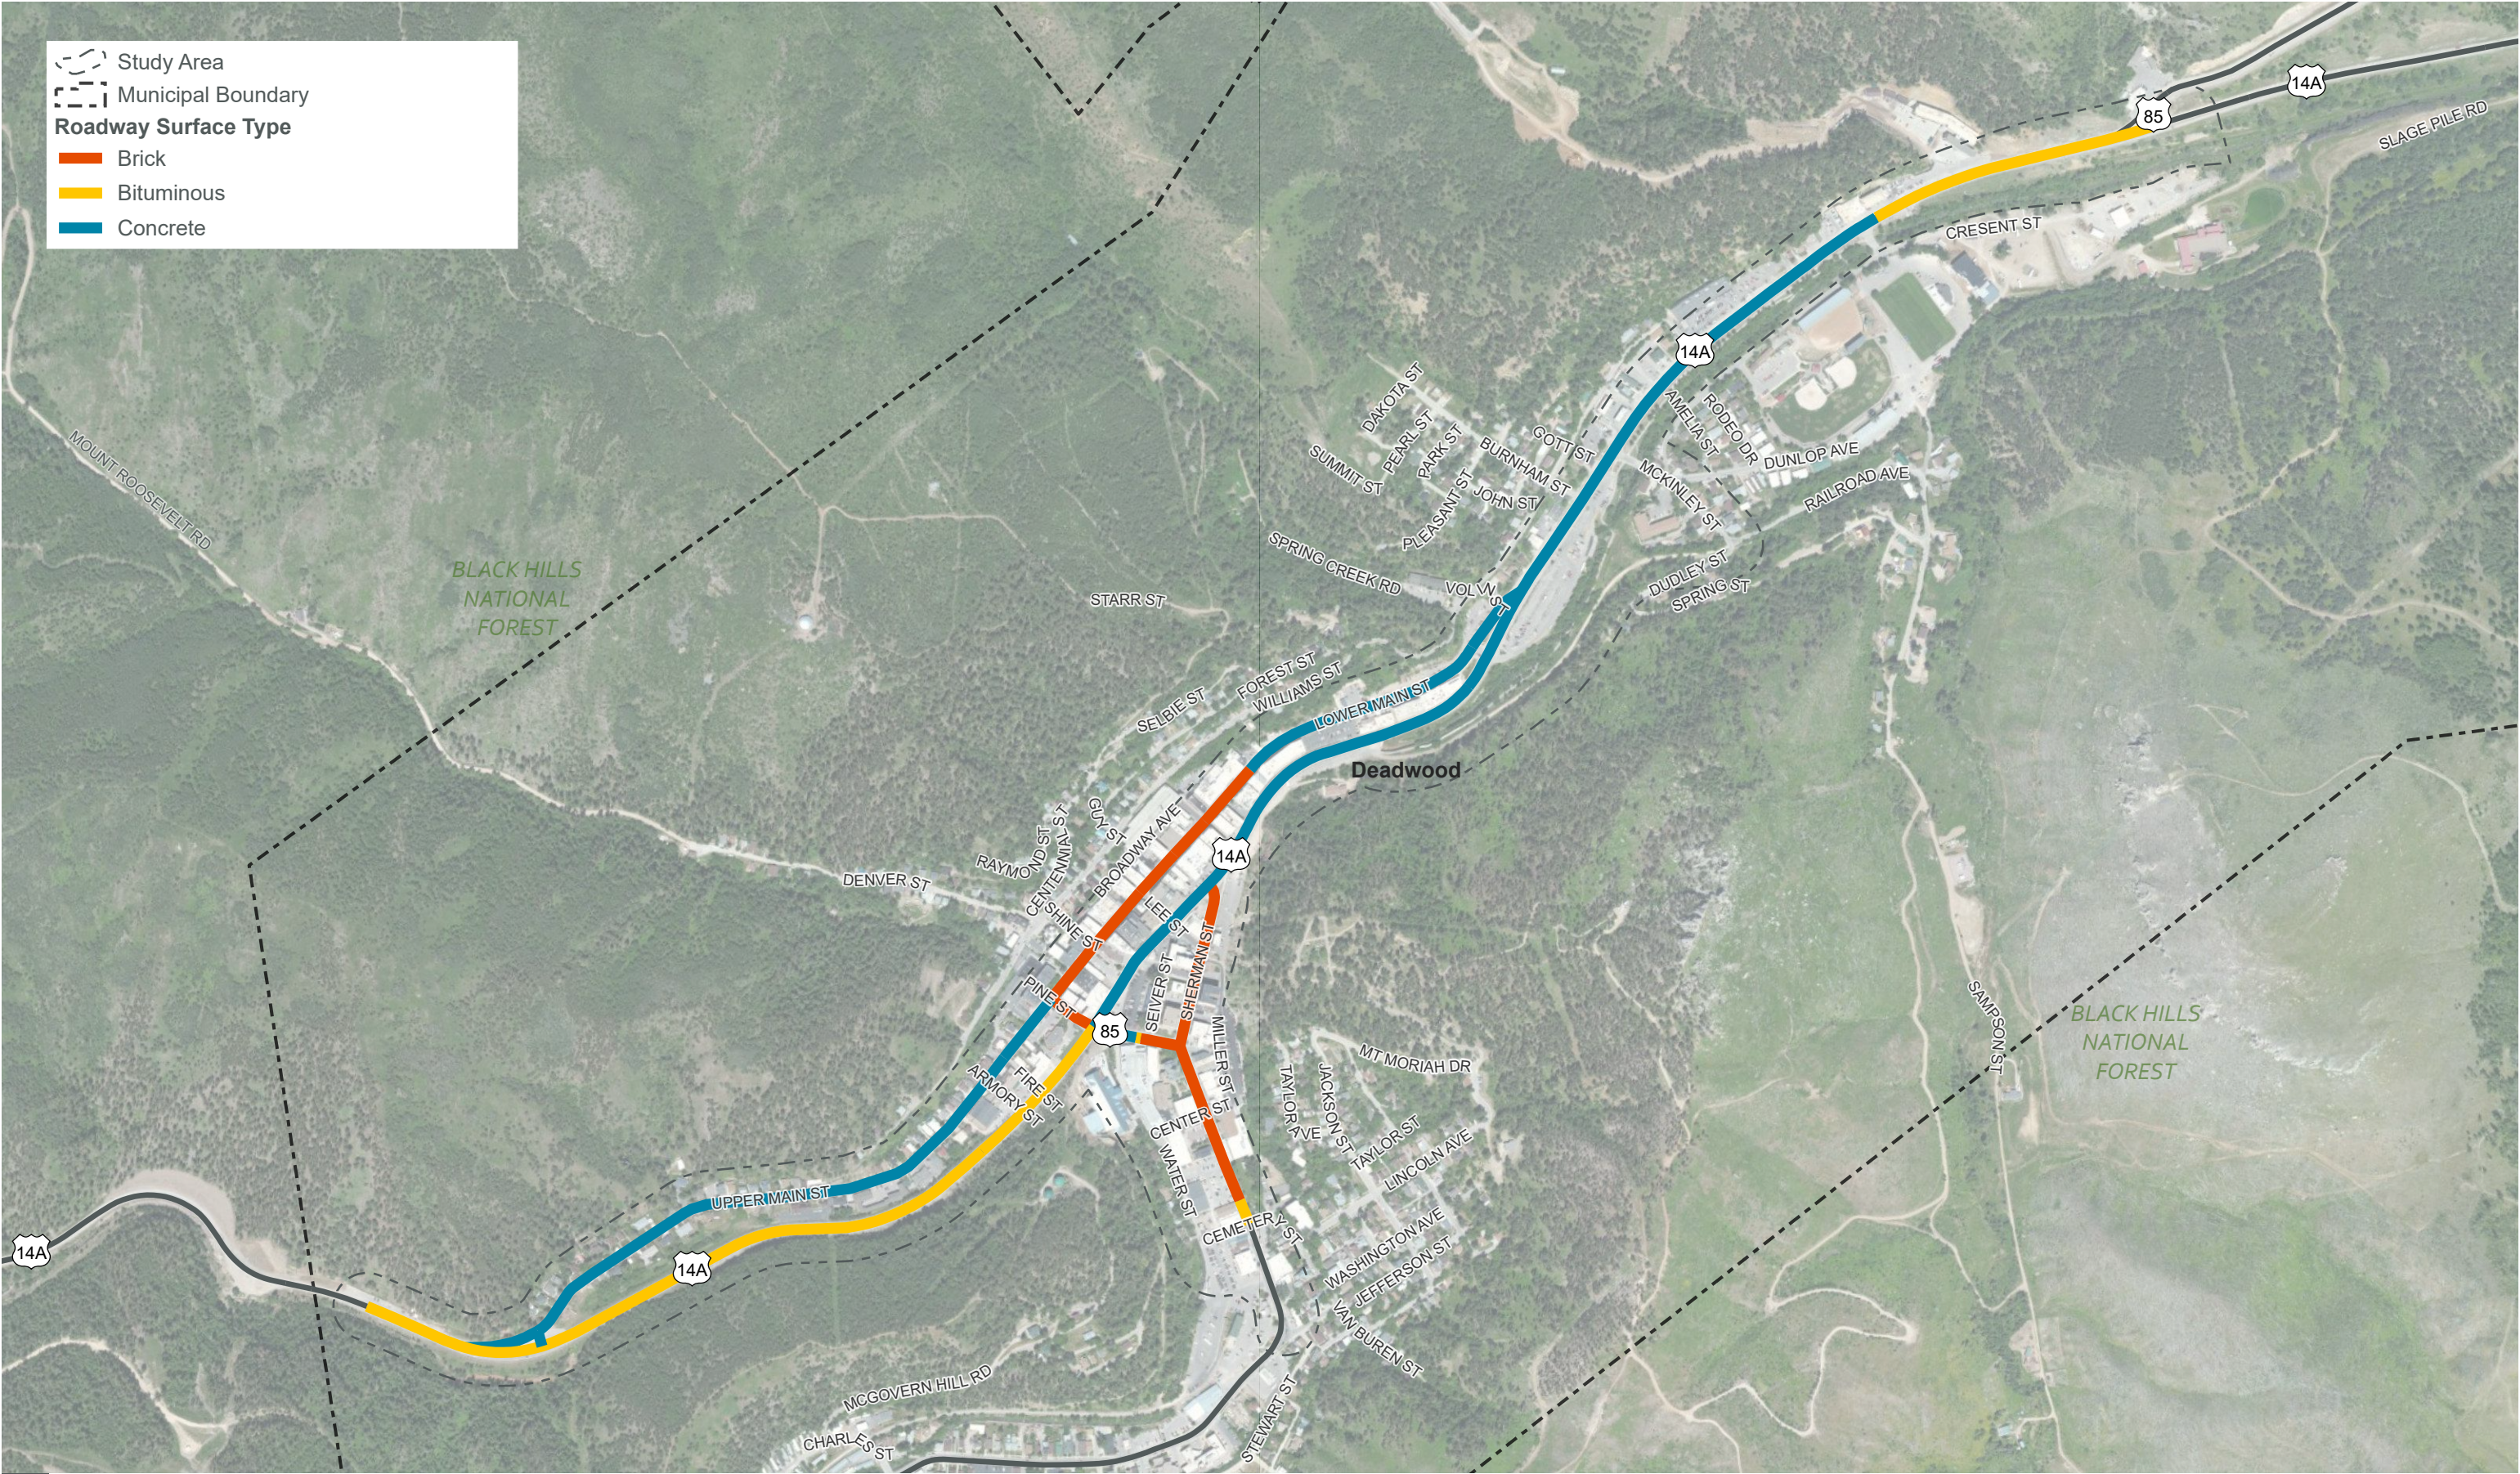
## EXISTING ROADWAY LANES, ROW WIDTHS, AND DAILY VOLUMES

The existing roadway sections range from 2 lane to 5 lane on the primary study corridors. The existing right of way widths range from 42 feet to 100 feet along the primary study corridors. Figure 11 visually summarizes the varying roadway typical sections and right of way widths throughout the Study Area.

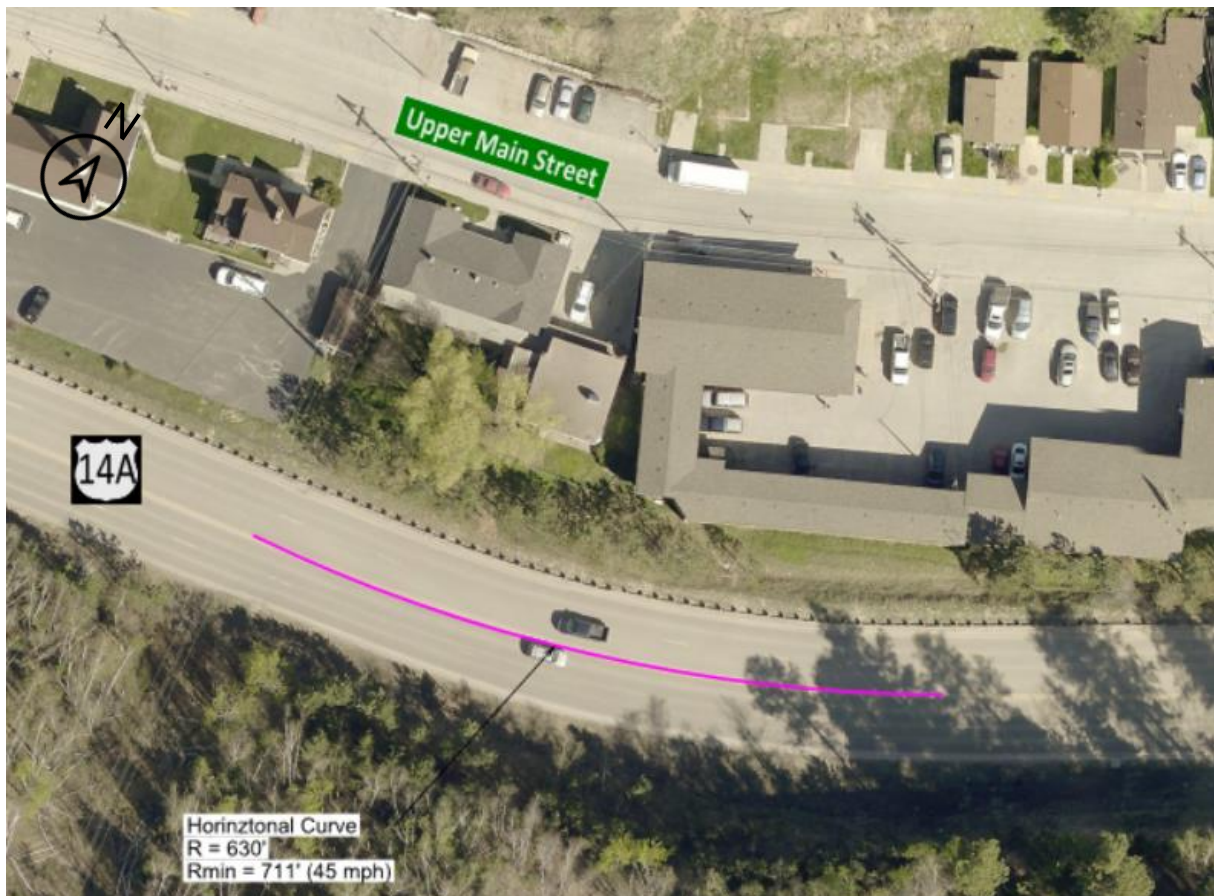
Figure 13. Horizontal Curve Review

The horizontal curve located along US14A to the south of the Gold Country Inn has a radius of 630 feet. The posted speed limit is 45 mph in this area. The minimum radius of a horizontal curve at 45 mph is 711 feet. The horizontal curve at this location has a radius less than the minimum radius required for a design speed of 45 mph. All other horizontal curves on US14A and US85 within the Study Area met or exceed the minimum radius based on their respective design speeds. This horizontal curve segment experienced three crashes between 2015 and 2019. Based on the segment length and exposure, the crash rate of this curve is similar to nearby horizontal curves that meet design speed criteria. The curve's segment crash rate also does not exceed the study-wide averaged critical crash rate.

The horizontal curve on US14A to the south of Gold Country Inn has a radius less than the minimum radius for the design speed of the roadway segment. There are several intersections with inadequate intersection sight distance or a high amount of skew including US14A and Deadwood Street, US14A and Lee Street, US14A and Wall Street, US14A and Sherman Street, and US14A and Lower Main Street. This horizontal curve and intersections should be reviewed during the build concept phase to determine if correcting these geometrics are feasible.

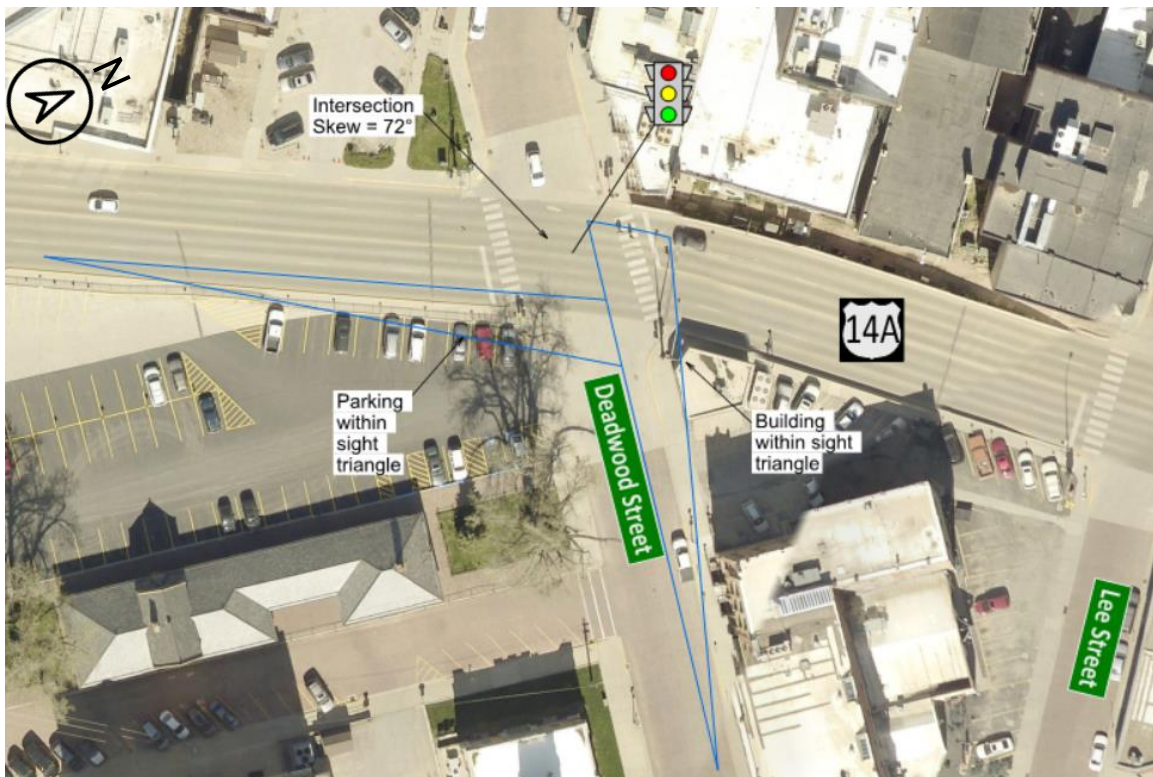
Figure 14. Intersection Geometrics at US14A and Deadwood Street

Departure sight triangles at intersections should be clear of obstructions (building, parking, trees, etc) and the intersection of the two streets optimally should be close to a right angle. Departure sight triangles with obstructions are shown in blue and orange within Figure 14 through Figure 18 below. Blue sight triangles are for right turns and orange sight triangles for left turns.

The intersection of Deadwood Street and US14A is located within the 25 mph speed limit zone and is signalized. The skew angle between Deadwood Street and US14A is 72 degrees. The sight triangle to the east of the southbound right-on-right turning maneuver is obstructed by the corner of the building within the northeast quadrant of the intersection. The sight triangle to the south of the westbound right-on-red turning maneuver is obstructed by parking within the southeast quadrant of the intersection. However, if a vehicle travels forward beyond the stop bar and into the crosswalk and before the lane of the conflicting traveled way, a vehicle has adequate sight distance to complete the maneuver. This intersection experienced the highest number of angle crashes of all study intersections, totaling five angle crashes. As described in the *Crash History Review Memo*, this intersection has an intersection crash rate less than the study-wide averaged critical crash rate. However, this intersection has the third highest Equivalent Property Damage Only (EPDO) rate of the study intersections. Meaning, of the crashes that do occur at this intersection, the crashes are more severe than the average similar type of intersection within the study area. This finding is consistent with the high number of angle crashes at this intersection.

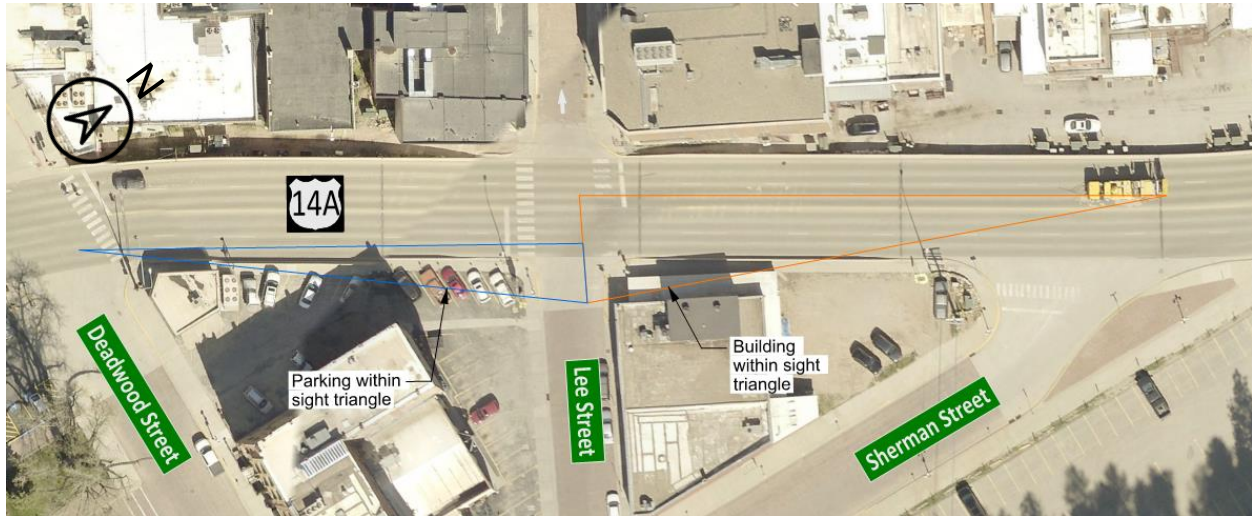
**Figure 15. Intersection Geometrics at US14A and Lee Street**

The intersection of Lee Street and US14A is located within the 25 mph speed limit zone and is unsignalized with two-way stop control from Lee Street. The west leg of Lee Street is a westbound one way street so the eastbound sight triangle from that leg is not applicable. The sight triangles are obstructed by parking within the southeast quadrant of the intersection and a building within the northeast quadrant of the intersection. If a vehicle travels forward beyond the stop bar and into the crosswalk and before the lane of the conflicting traveled way, a vehicle has adequate sight distance to complete the maneuvers previously listed. The crash history at this intersection did not indicate higher than average crash rates.

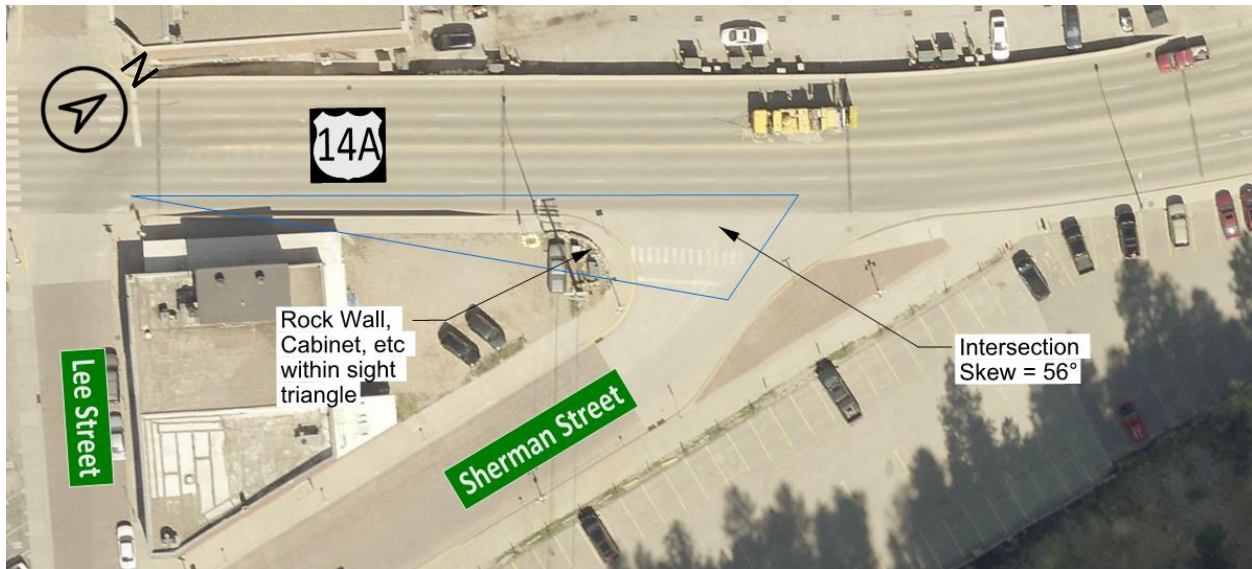
Figure 16. Intersection Geometrics at US14A and Sherman Street

The intersection of Sherman Street and US14A / Pioneer Way has a skew less than 60 degrees and the approach angles have an even greater amount of skew. The sight distance to the south is limited by a rock wall, utility cabinet, power pole, light poles, jersey barrier, bollards, and signs. As described in the *Crash History Review Memo*, this intersection experienced six crashes between 2015 and 2019 and is one of two study intersections with a crash rate that exceeds the critical crash rate. All six crashes were rear-ends and took place on the Sherman Street approach of the intersection. According to the traffic reports, the leading description of driver contribution to the crash was failure to yield and distraction. One of the potential reasons for these rear-end crashes is the skew of the intersection. The skew may give unfamiliar drivers the illusion of Sherman Street being the thru movement with US14A.

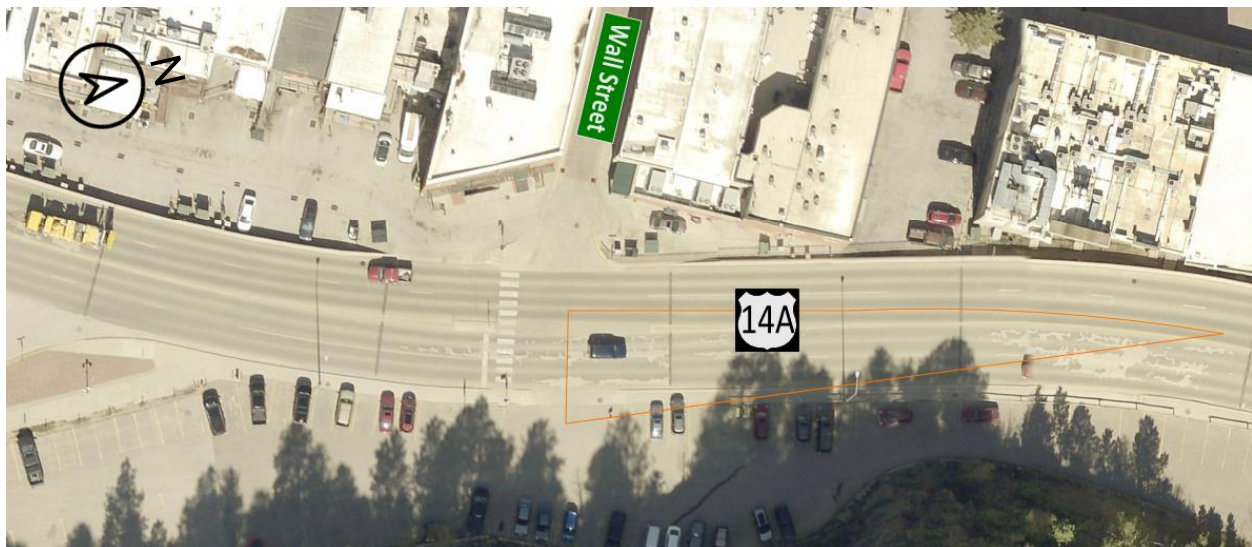
Figure 17. Intersection Geometrics at US14A and Wall Street

The intersection of Wall Street and US14A is located within the 25 mph speed limit zone and is unsignalized with stop control from the Parking Area across from Wall Street. The west leg of Wall Street is a westbound one way street so the eastbound sight triangle from that leg is not applicable. The sight triangle to the north is obstructed by parking within the northeast quadrant of the intersection. If a vehicle travels forward into the crosswalk and before the lane of the conflicting traveled way, a vehicle has adequate sight distance to complete the maneuver. As described in the *Crash History Review Memo*, this intersection experienced eight crashes between 2015 and 2019 and is one of two study intersections with a crash rate that exceeds the study-wide averaged critical crash rate.

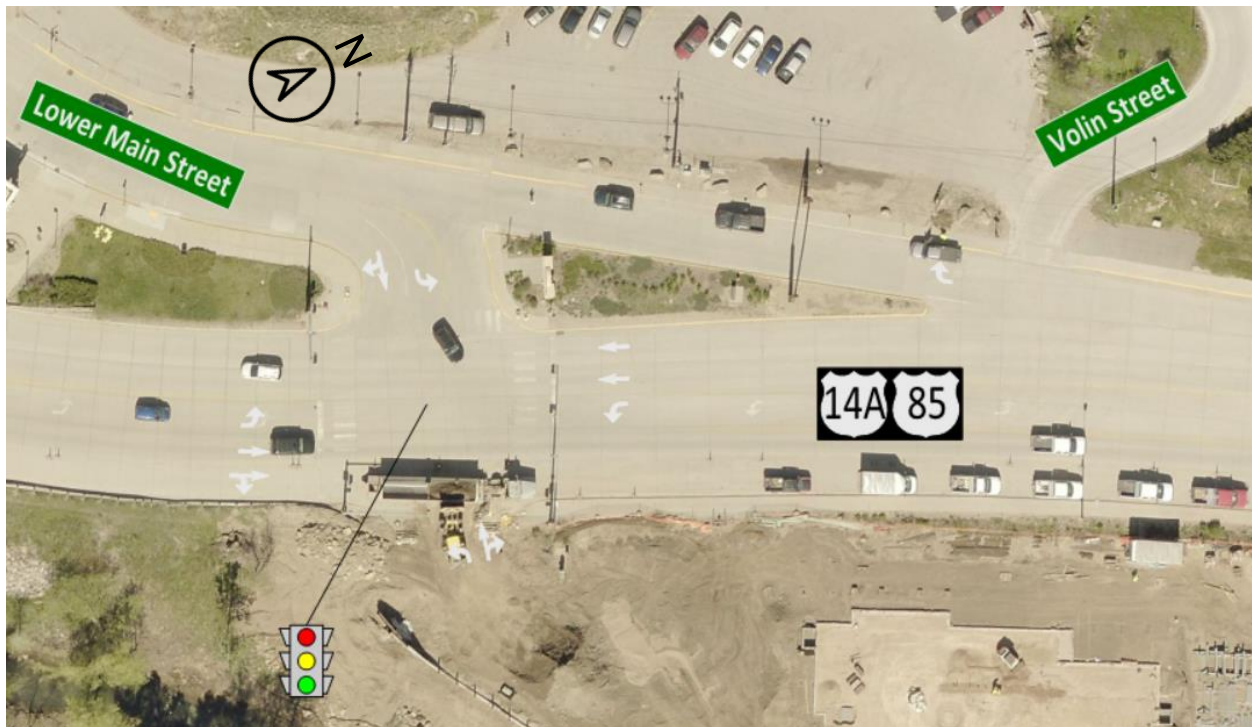
Figure 18. Intersection Geometrics at US14A and Lower Main Street

The intersection of Lower Main Street and US14A / Pioneer Way is atypical. Before US14A was built, Main Street was the thru movement with US 85 going through the downtown area. The construction of US14A required a retrofit situation with Lower Main Street, an intersection with a high amount of skew, and a slip ramp for southbound right turning traffic. The slip ramp maintains a direct inbound historic Main Street route/'gateway'. The approach angles for the eastbound left and right turns is less than optimal. However, the departure sight triangles for all turning maneuvers do not have obstructions within them. Volin Street intersects with the southbound right slip ramp and within the influence area of the intersection. The crash history at this intersection did not indicate higher than average crash rates.

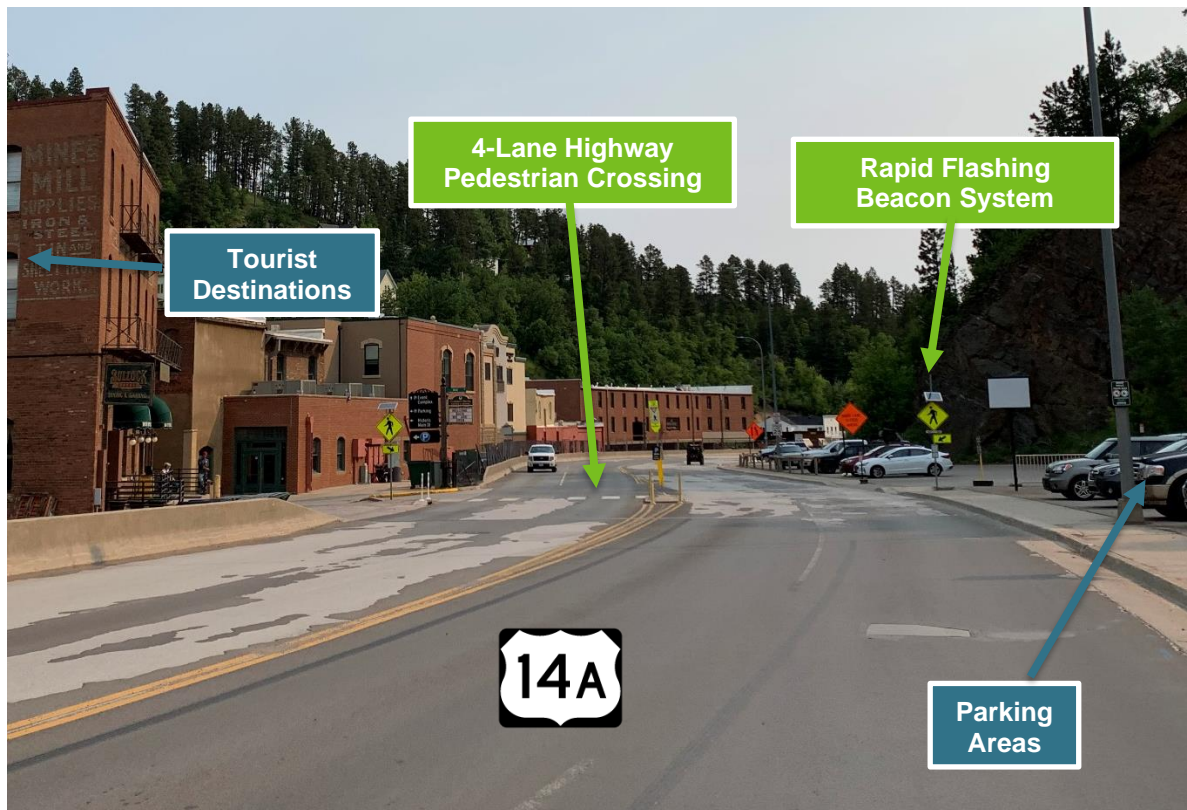
Pedestrian facilities through town include curbside sidewalks of varying widths, as shown in Figure 24. There are cross walks at signalized intersections and unsignalized intersections with pedestrian-actuated rapid flashing beacons at popular crossing locations. There are two main unsignalized crosswalks across US14A including one at Wall Street, as shown in Figure 20, and one at Lee Street. The City has received several complaints about these crosswalks over the years. The 2008 Deadwood Pedestrian Circulation and Enhancement Study cited that pedestrians were unlikely to use the buttons that actuate the rapid flashing beacons. In addition, the distance of the crosswalk, the speed at which traffic was traveling on US14A and the volume of traffic were intimidating to pedestrians that need to cross. The demographics of pedestrians is widely varied from families to older generations and proposed designs should accommodate a variety of walking speeds.

Figure 20. Crosswalk with Rapid Flashing Beacon across US14A at Wall Street
