# Technical Memo

Project: US14A / US85 Deadwood Box Corridor Study

Subject: Existing Conditions **DRAFT**

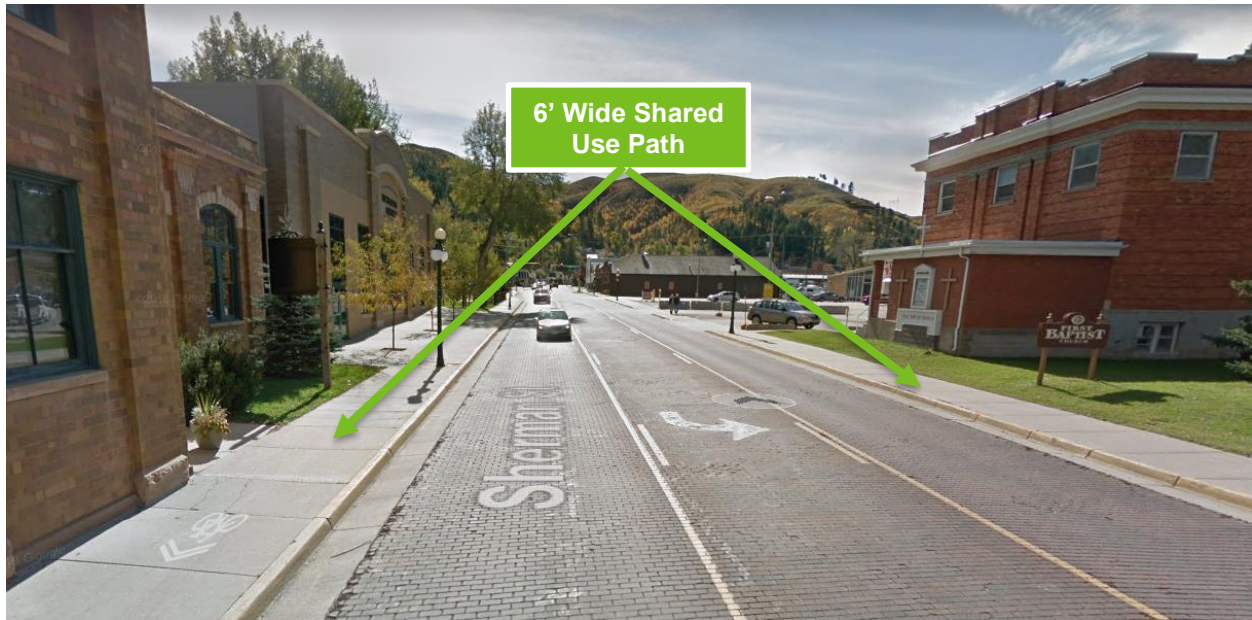
The multi-use paths and trails are shown in Figure 24 along with plans for future expansions of the trail systems. Currently, the trails are not connected with shared-use facilities that are wide enough to accommodate both pedestrian and bicycle traffic. Sidewalks 6 feet or less along both sides of Sherman Street and the east side of US14A serve as the network connections between the recreational trails. The sidewalks along Sherman Street are currently striped and signed as bicycle routes, even though they do not meet width requirements, and are heavily utilized by bicyclists making the connection between the Mickelson Trail and Whitewood Creek Trail. The 6 foot sidewalk along the east side of US14A has signage for bicyclists to dismount due to the narrow sidewalk, light poles, and frequent pedestrian usage.

**Figure 21. Shared Use Path Designation on Sherman Street's Sidewalks (Facing South)**

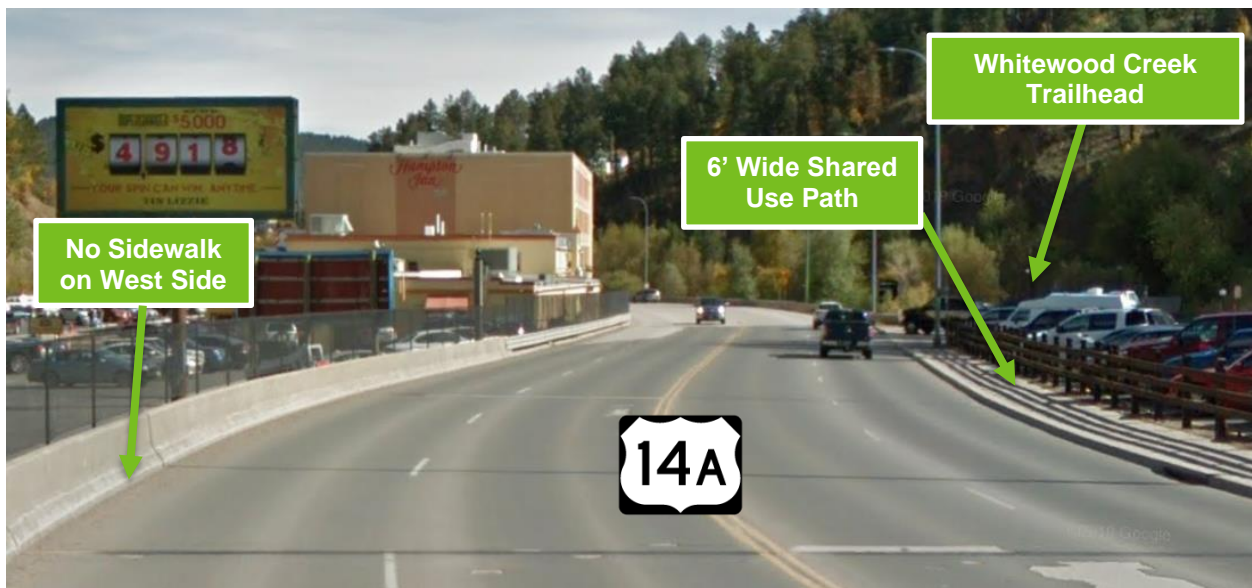
**Figure 22. Shared Use Path Designation on US14A East Sidewalk (Facing North)**

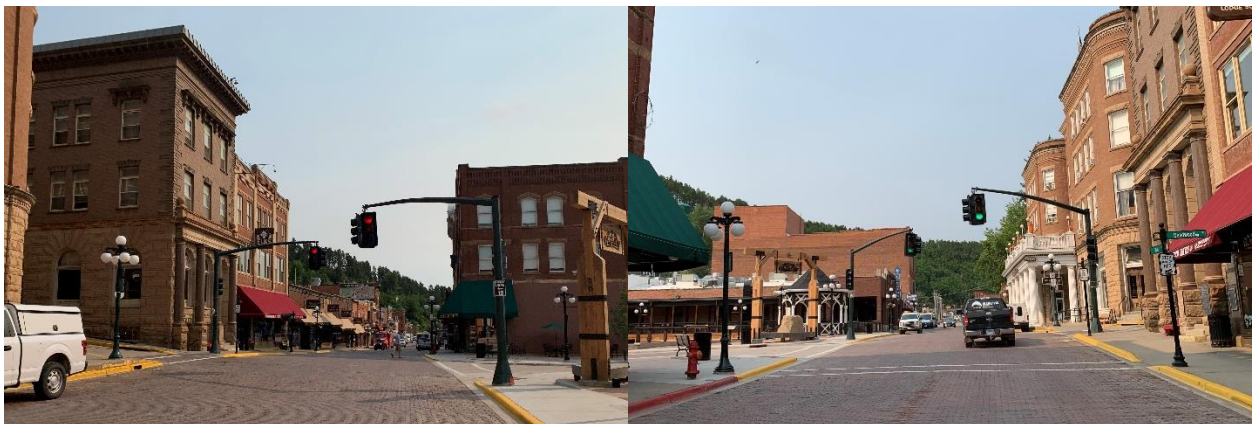
The current intersection of Main Street and Deadwood Street / Shine Street does not include pedestrian signal heads with countdown timers. Recent improvements to this intersection line up the previously offset streets of Deadwood Street and Shine Street. Although not a main study intersection, the City may want to have this signal reviewed for meeting warrants. Based on conversations with the City, there have been several close calls between pedestrians and vehicles. Although, zero pedestrian-vehicle crashes were reported to the state in the past 5-years. Pedestrians may tend to ignore the signal indications due to the absence of pedestrian signal heads and the lack of traffic on Shine Street. Vehicles heading eastbound on Shine Street see the green indication and may assume it is safe to proceed. Inadequate sight distance due to building corners block the view to see some of the pedestrian movements.

**Figure 23. Signalized Intersection at Main Street and Deadwood Street/Shine Street  
Looking North (Left Photograph), Looking South (Right Photograph)**

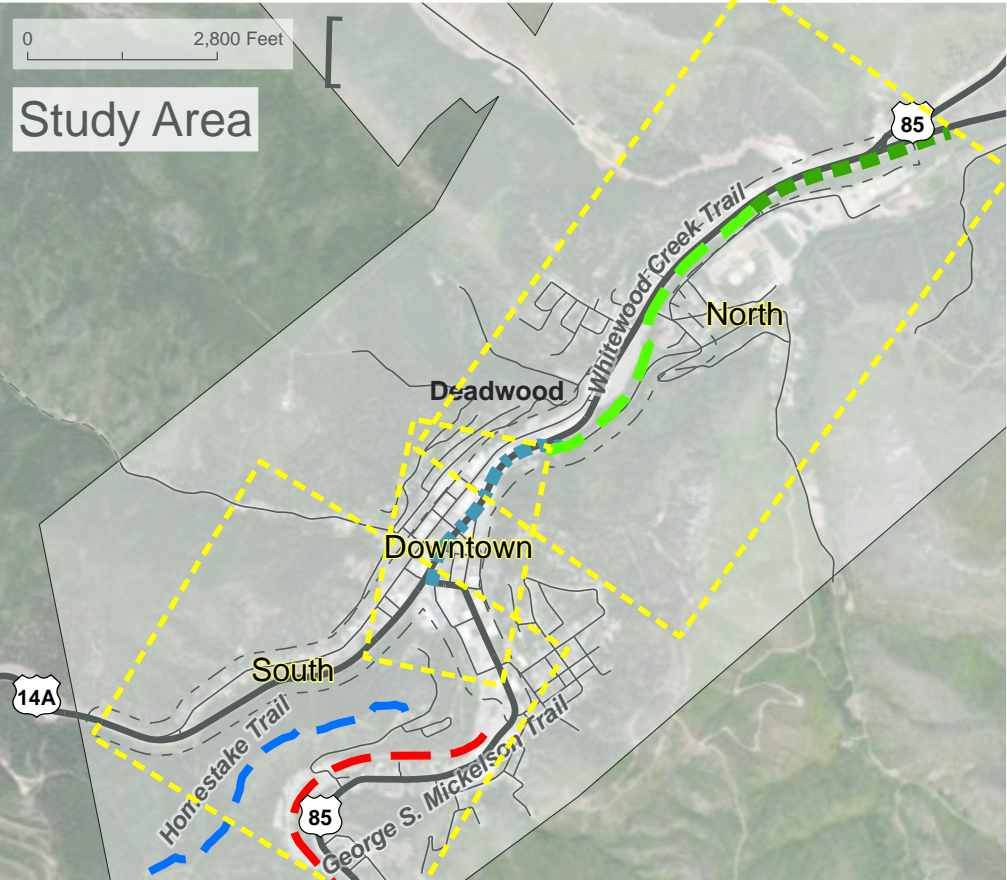
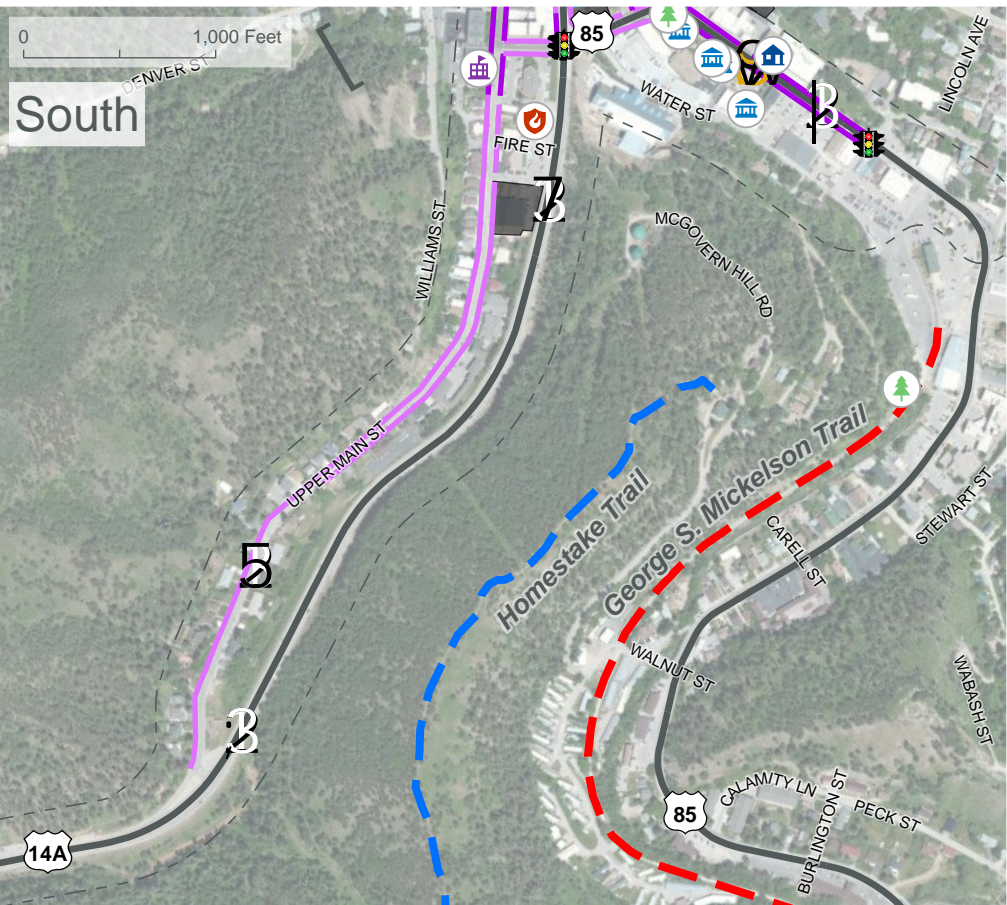
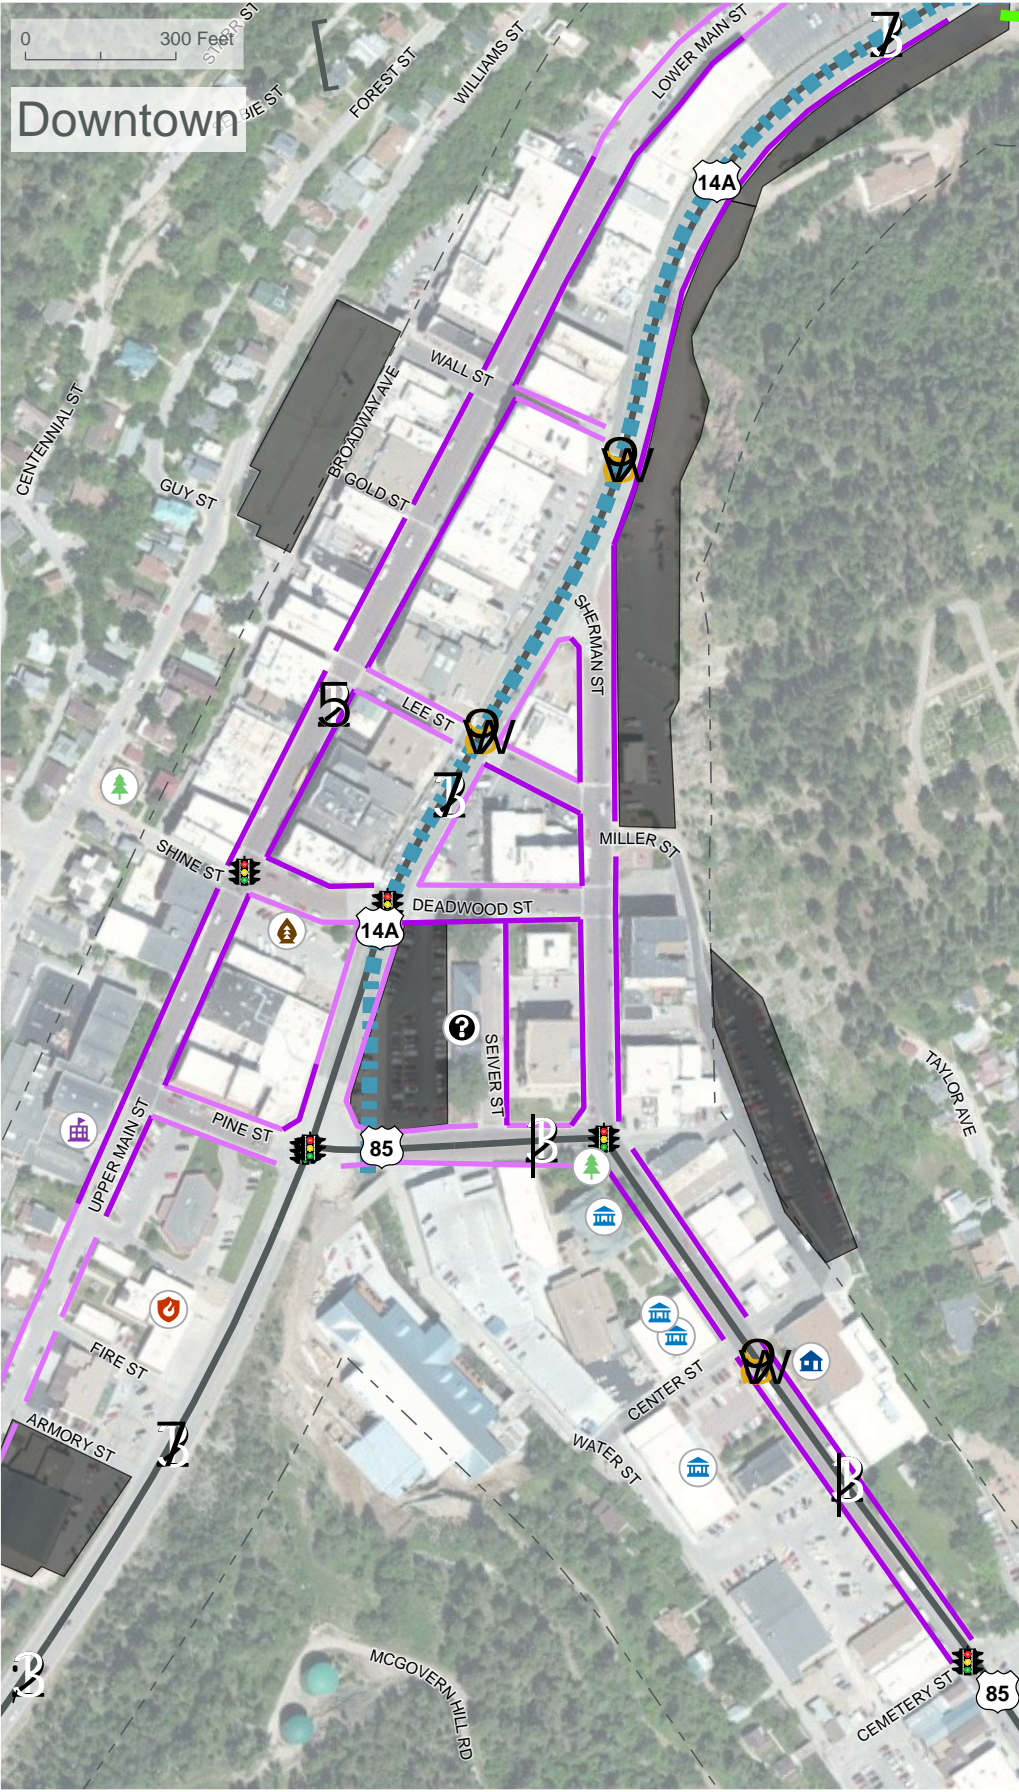
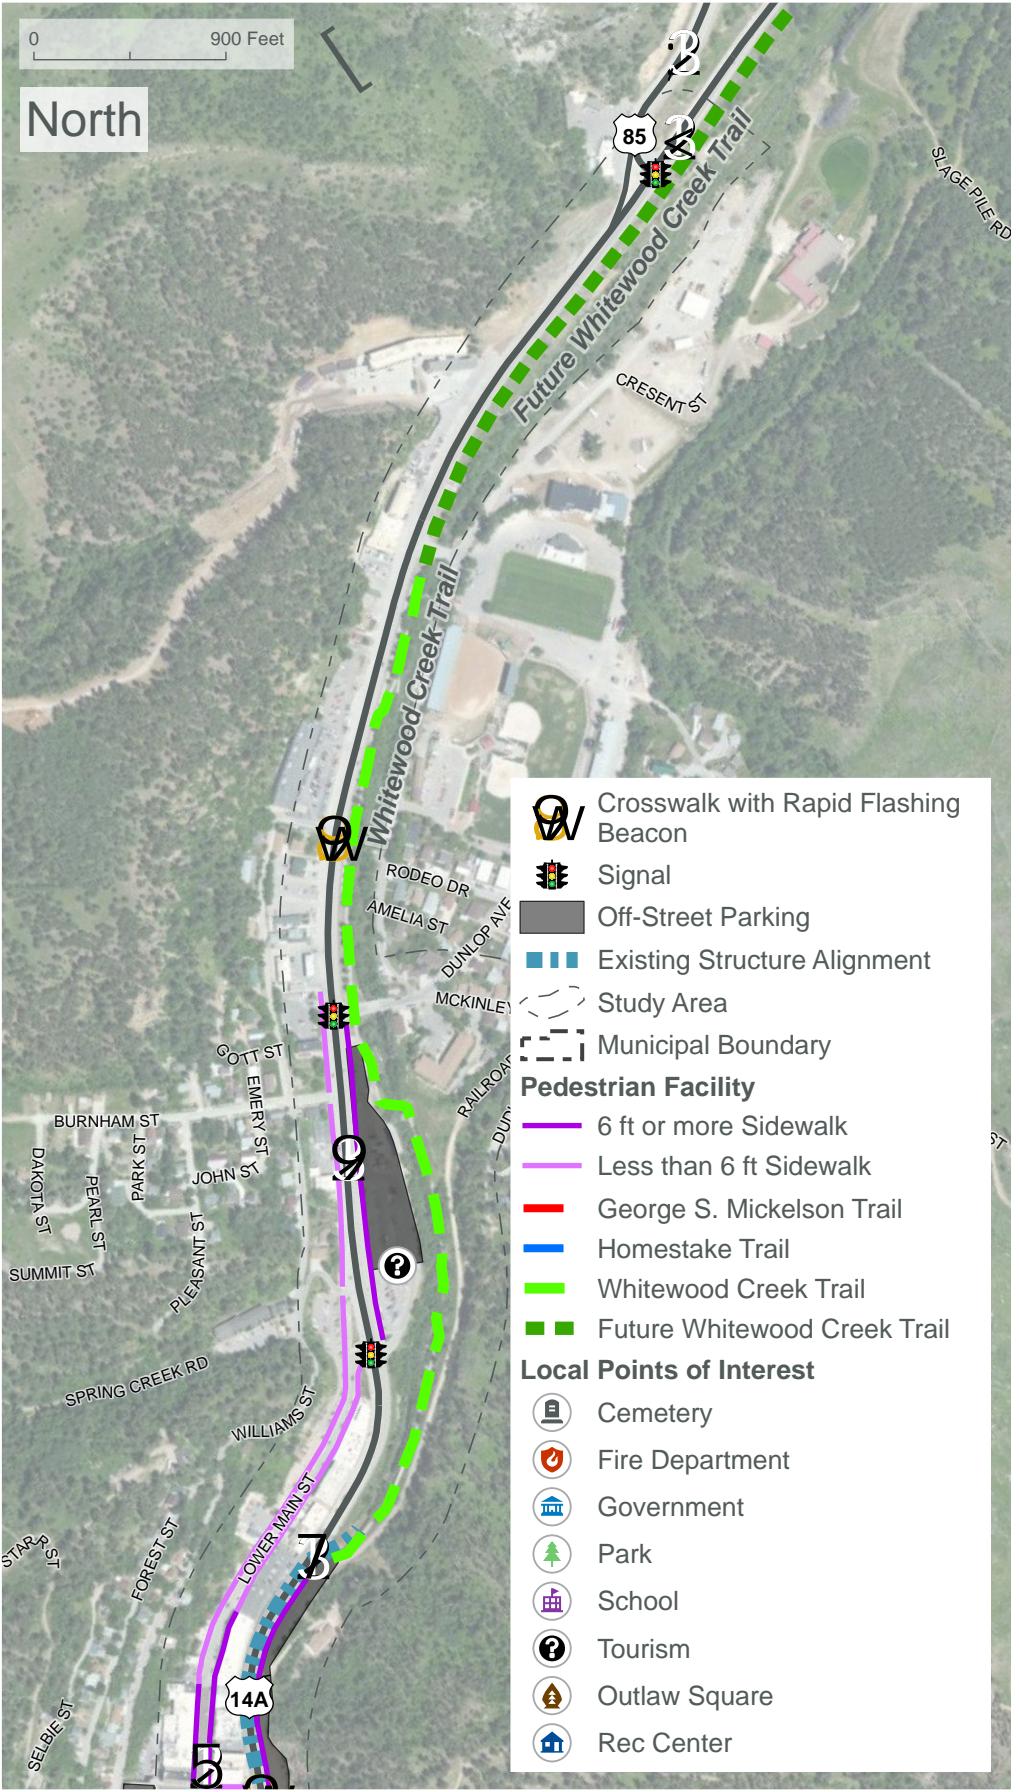
MULTI-MODAL (PEDESTRIAN & BICYCLE)  
FIGURE 24

Pedestrian facilities through town include curbside sidewalks of varying widths, as shown in Figure 24. There are cross walks at signalized intersections and unsignalized intersections with pedestrian-actuated rapid flashing beacons at popular crossing locations. There are two main unsignalized crosswalks across US14A including one at Wall Street, as shown in Figure 20, and one at Lee Street. The City has received several complaints about these crosswalks over the years. The 2008 Deadwood Pedestrian Circulation and Enhancement Study cited that pedestrians were unlikely to use the buttons that actuate the rapid flashing beacons. In addition, the distance of the crosswalk, the speed at which traffic was traveling on US14A and the volume of traffic were intimidating to pedestrians that need to cross. The demographics of pedestrians is widely varied from families to older generations and proposed designs should accommodate a variety of walking speeds.

There is a need for a 10 foot wide shared use sidewalk between the Mickelson Trailhead and the Whitewood Creek Trailhead. With the future plans for expansion of the Whitewood Creek Trail, the lack of a shared use path along Sherman Street and US14A is a missing link for the potential northern expansion of the Michelson Trail system to Sturgis or Whitewood.

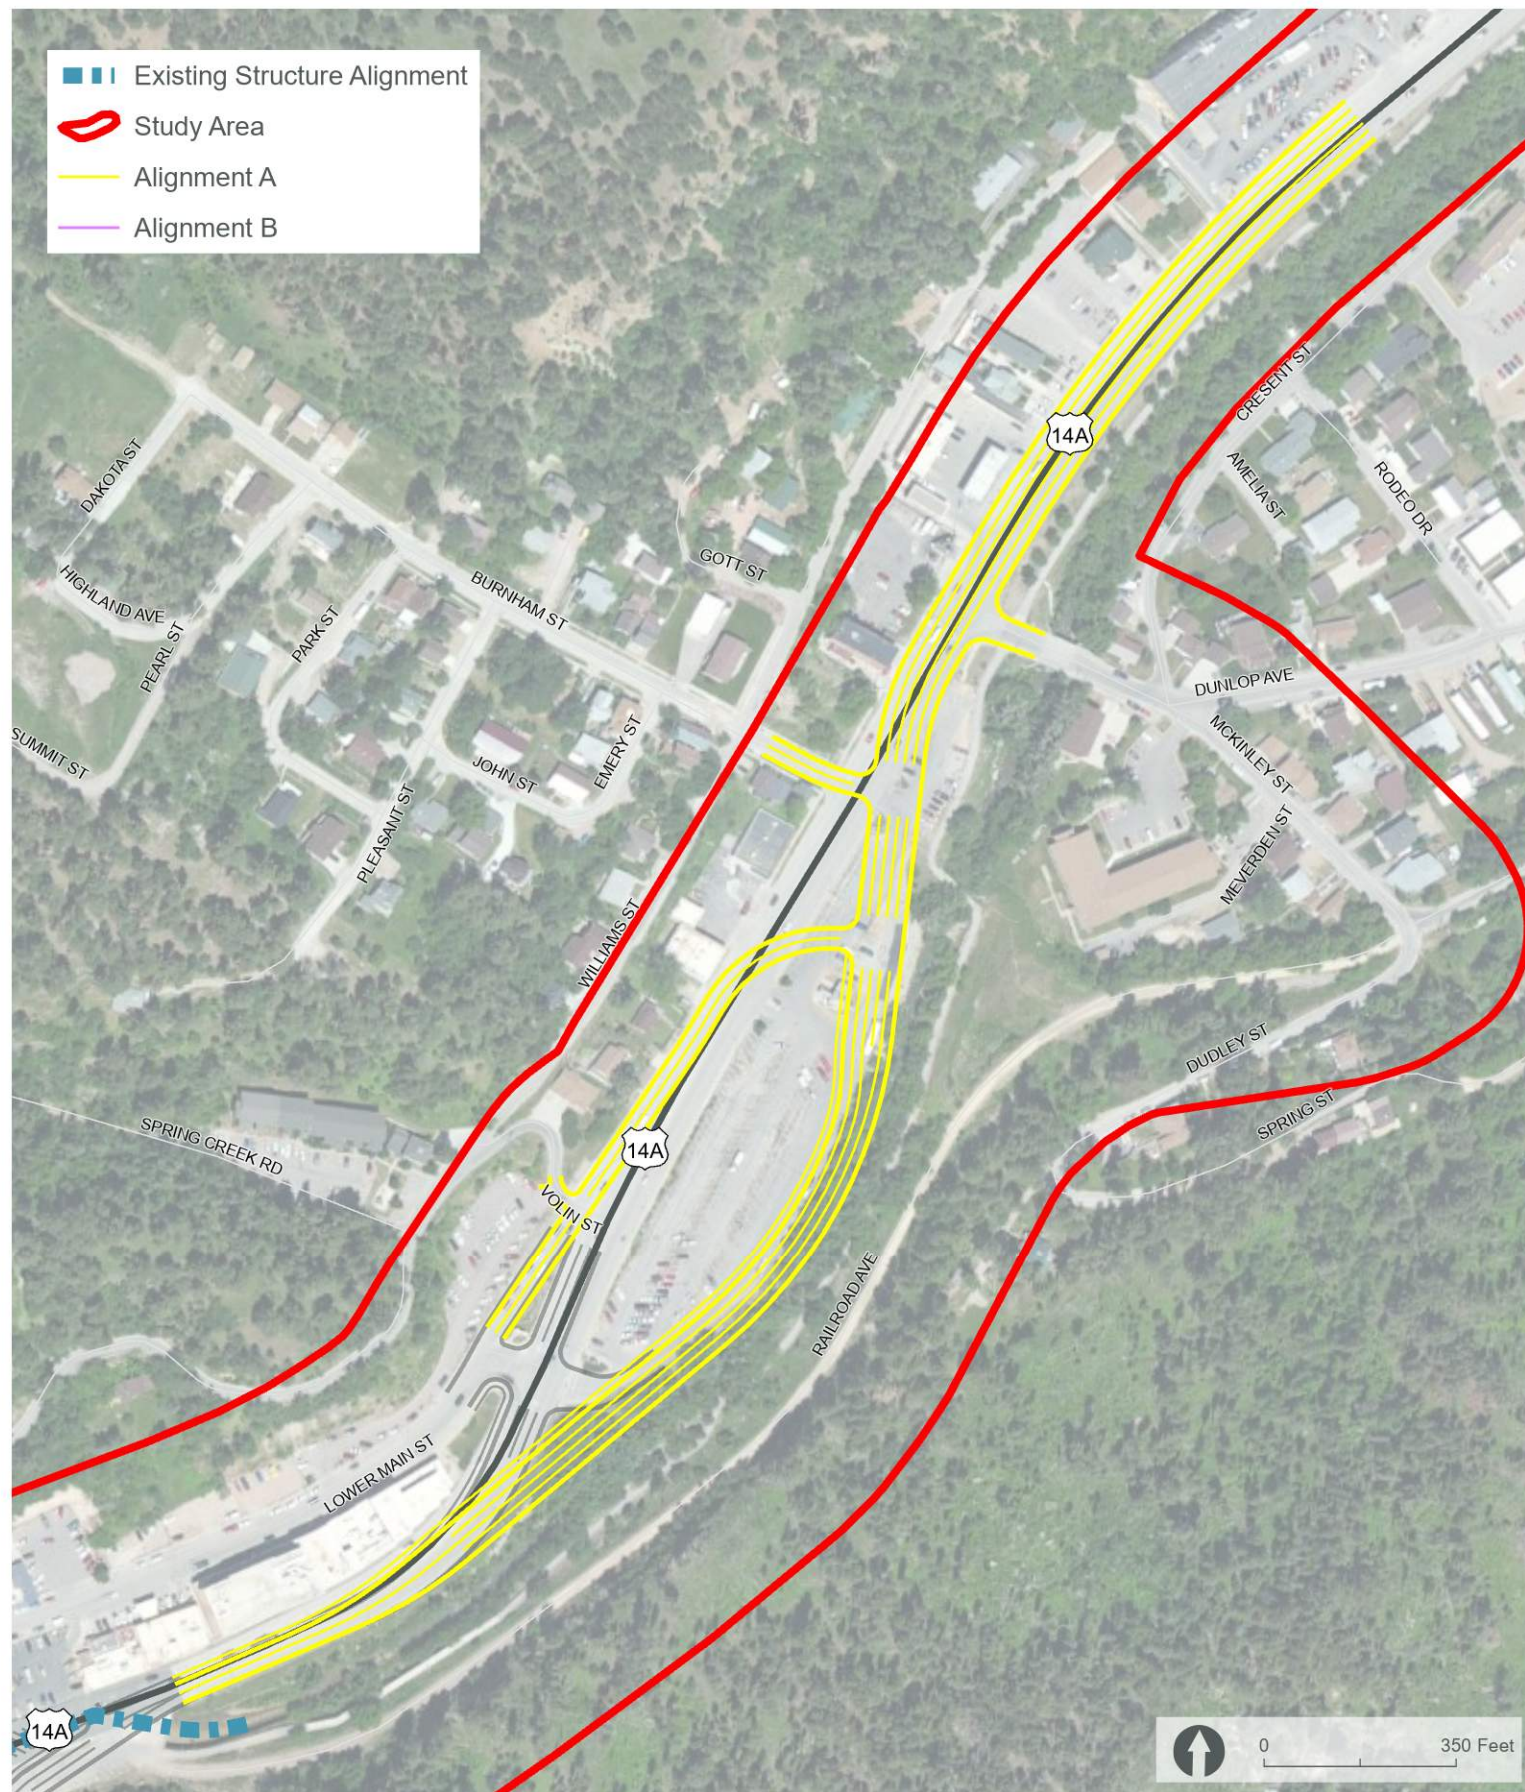
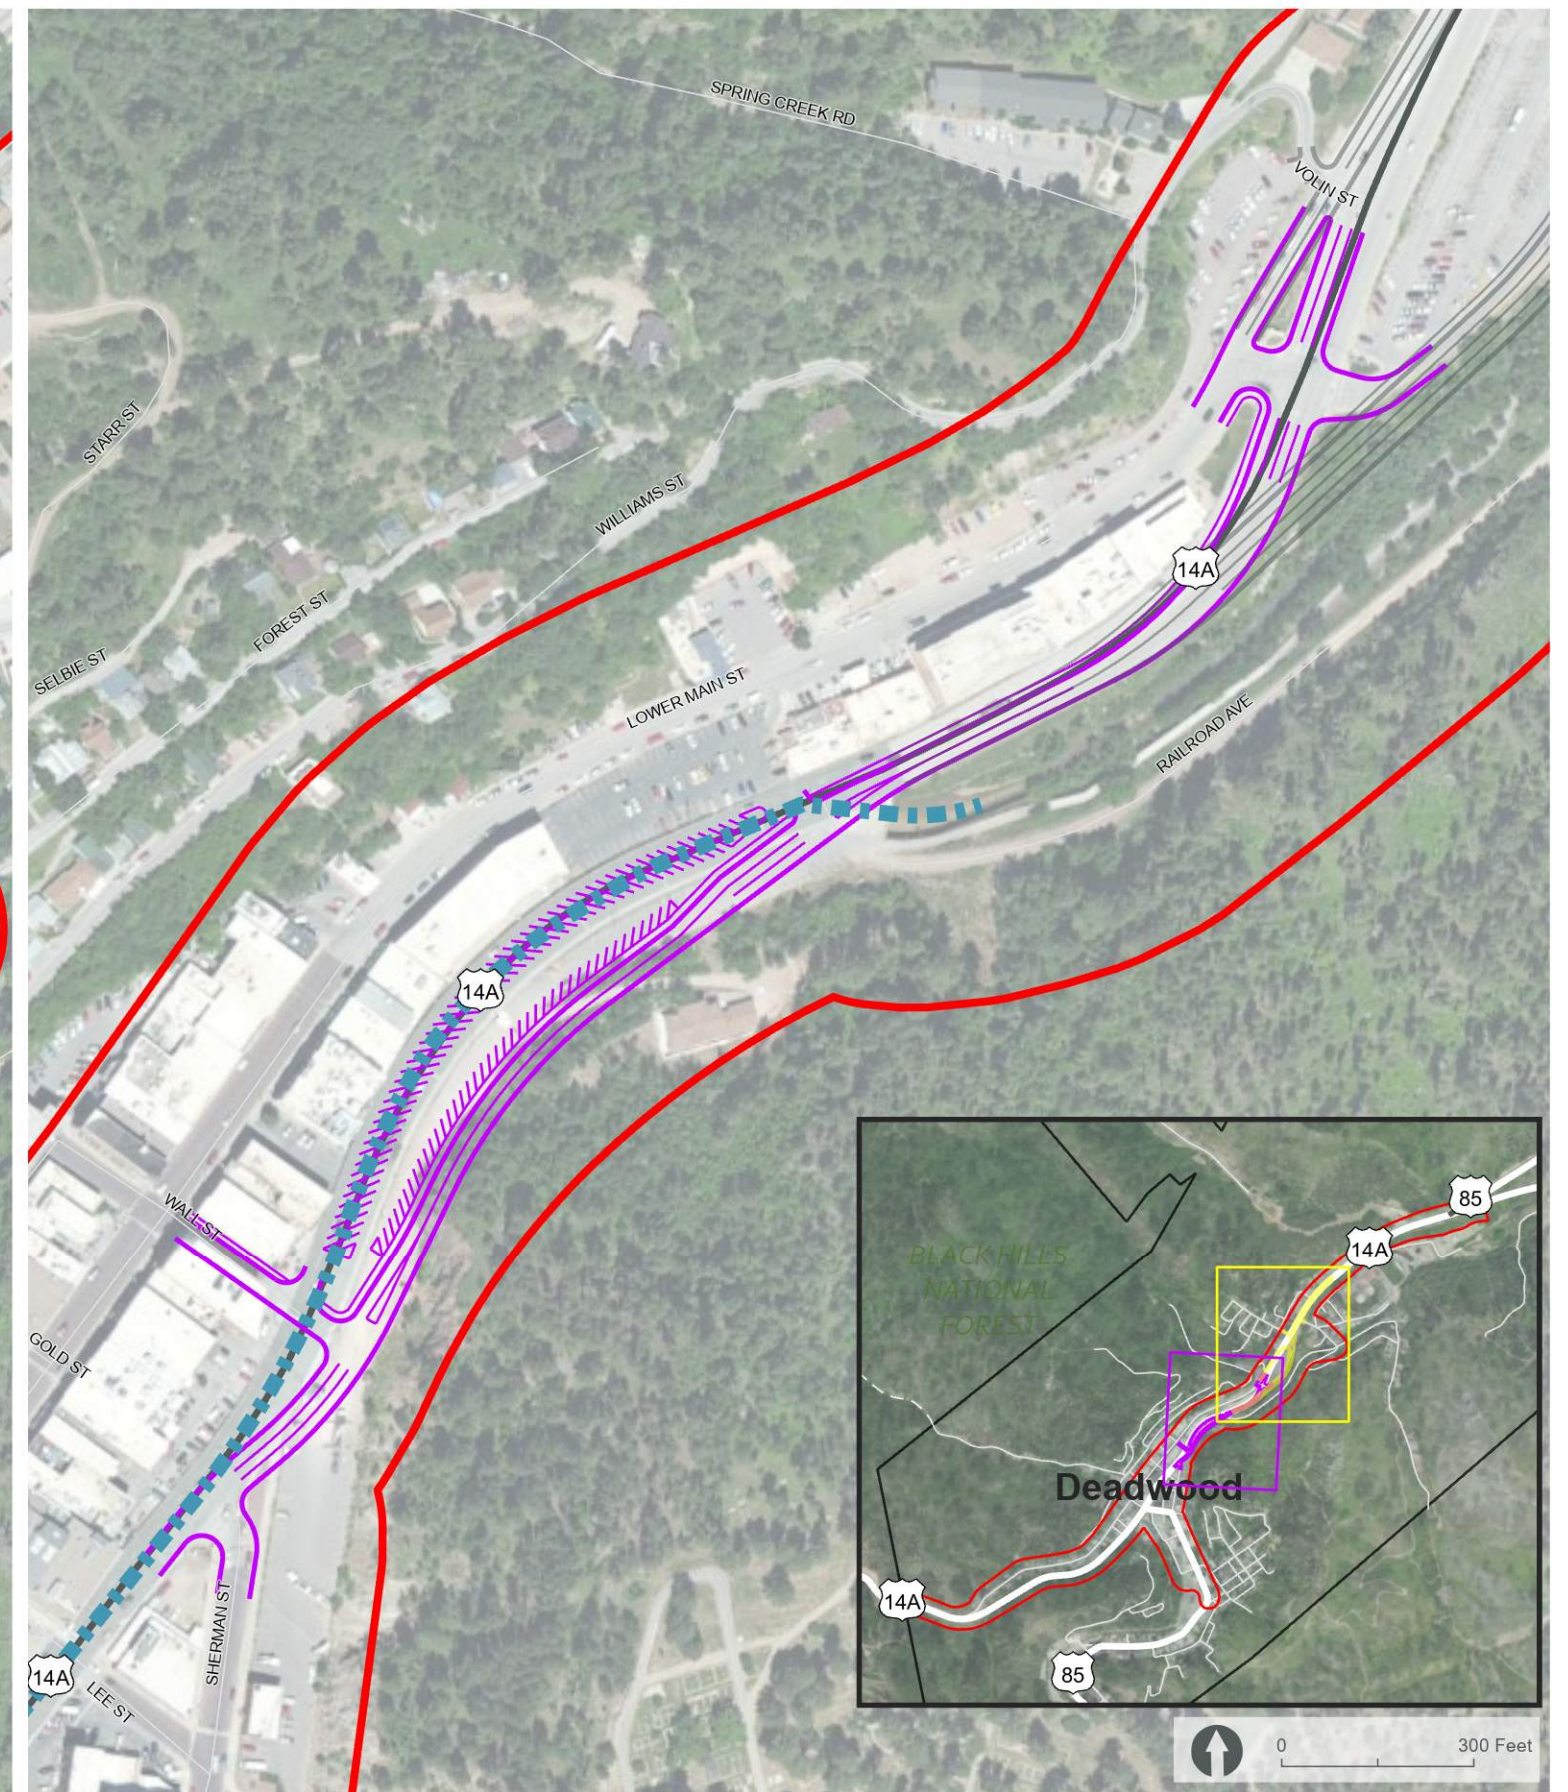
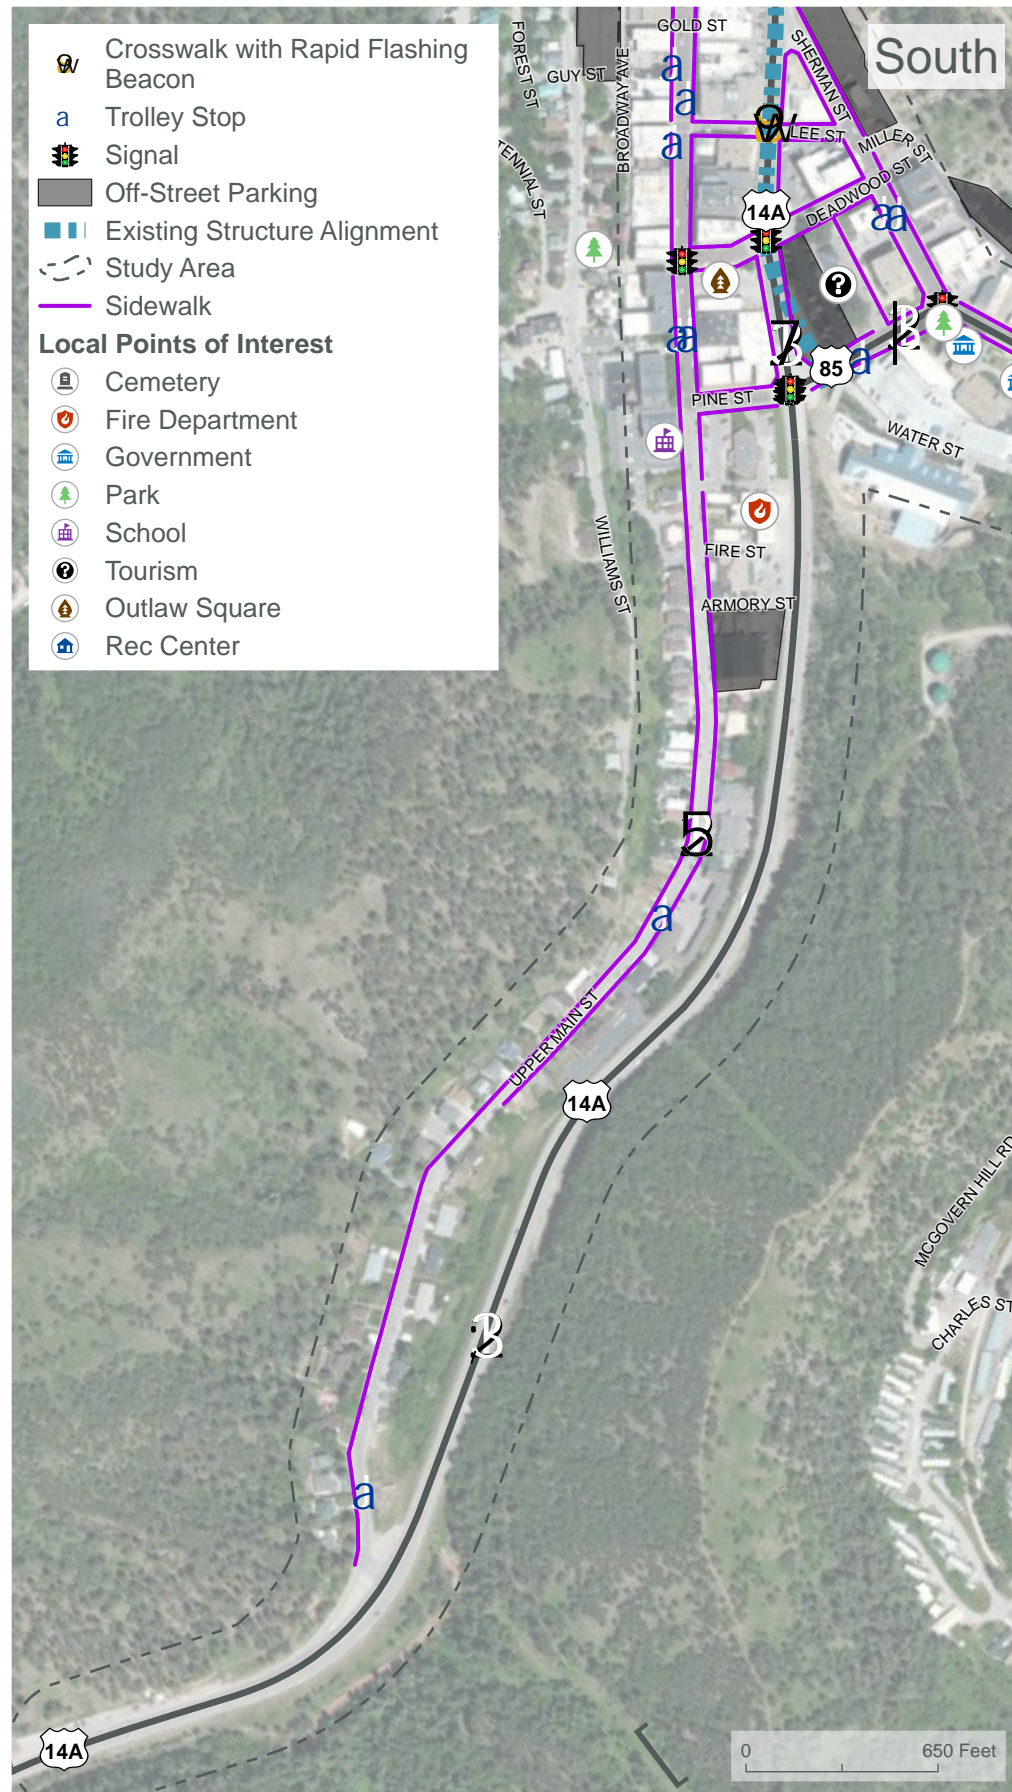
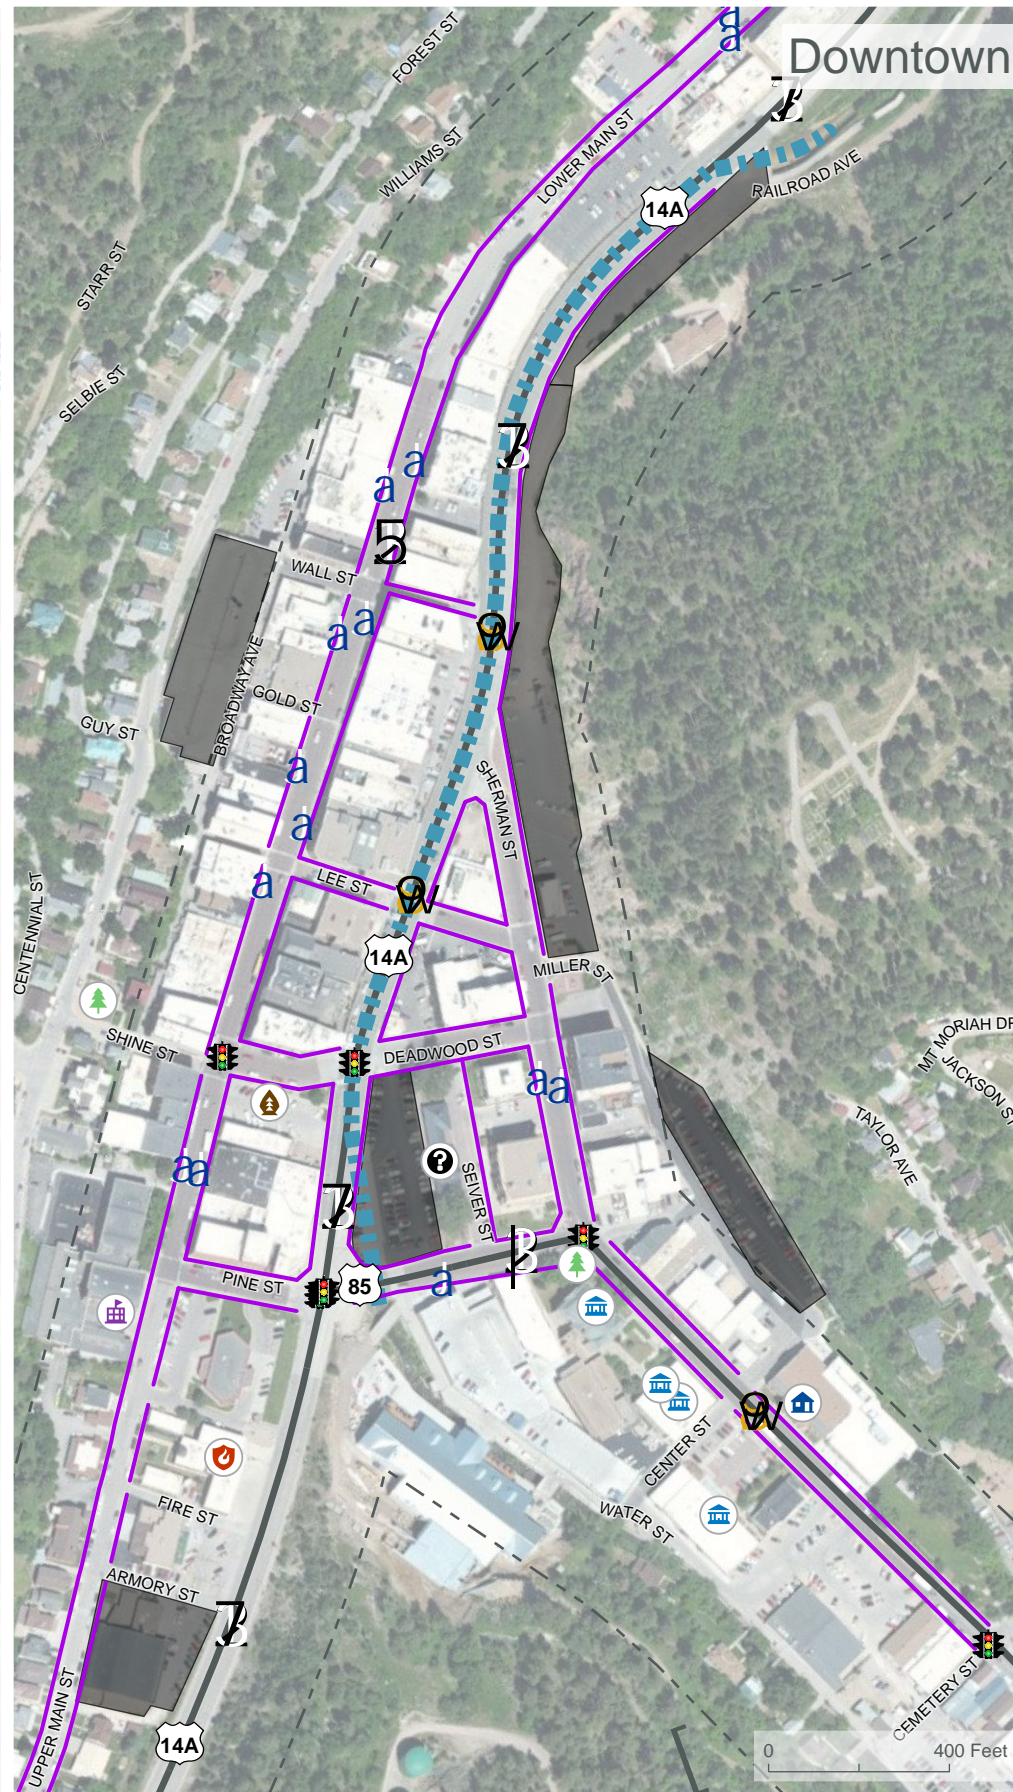
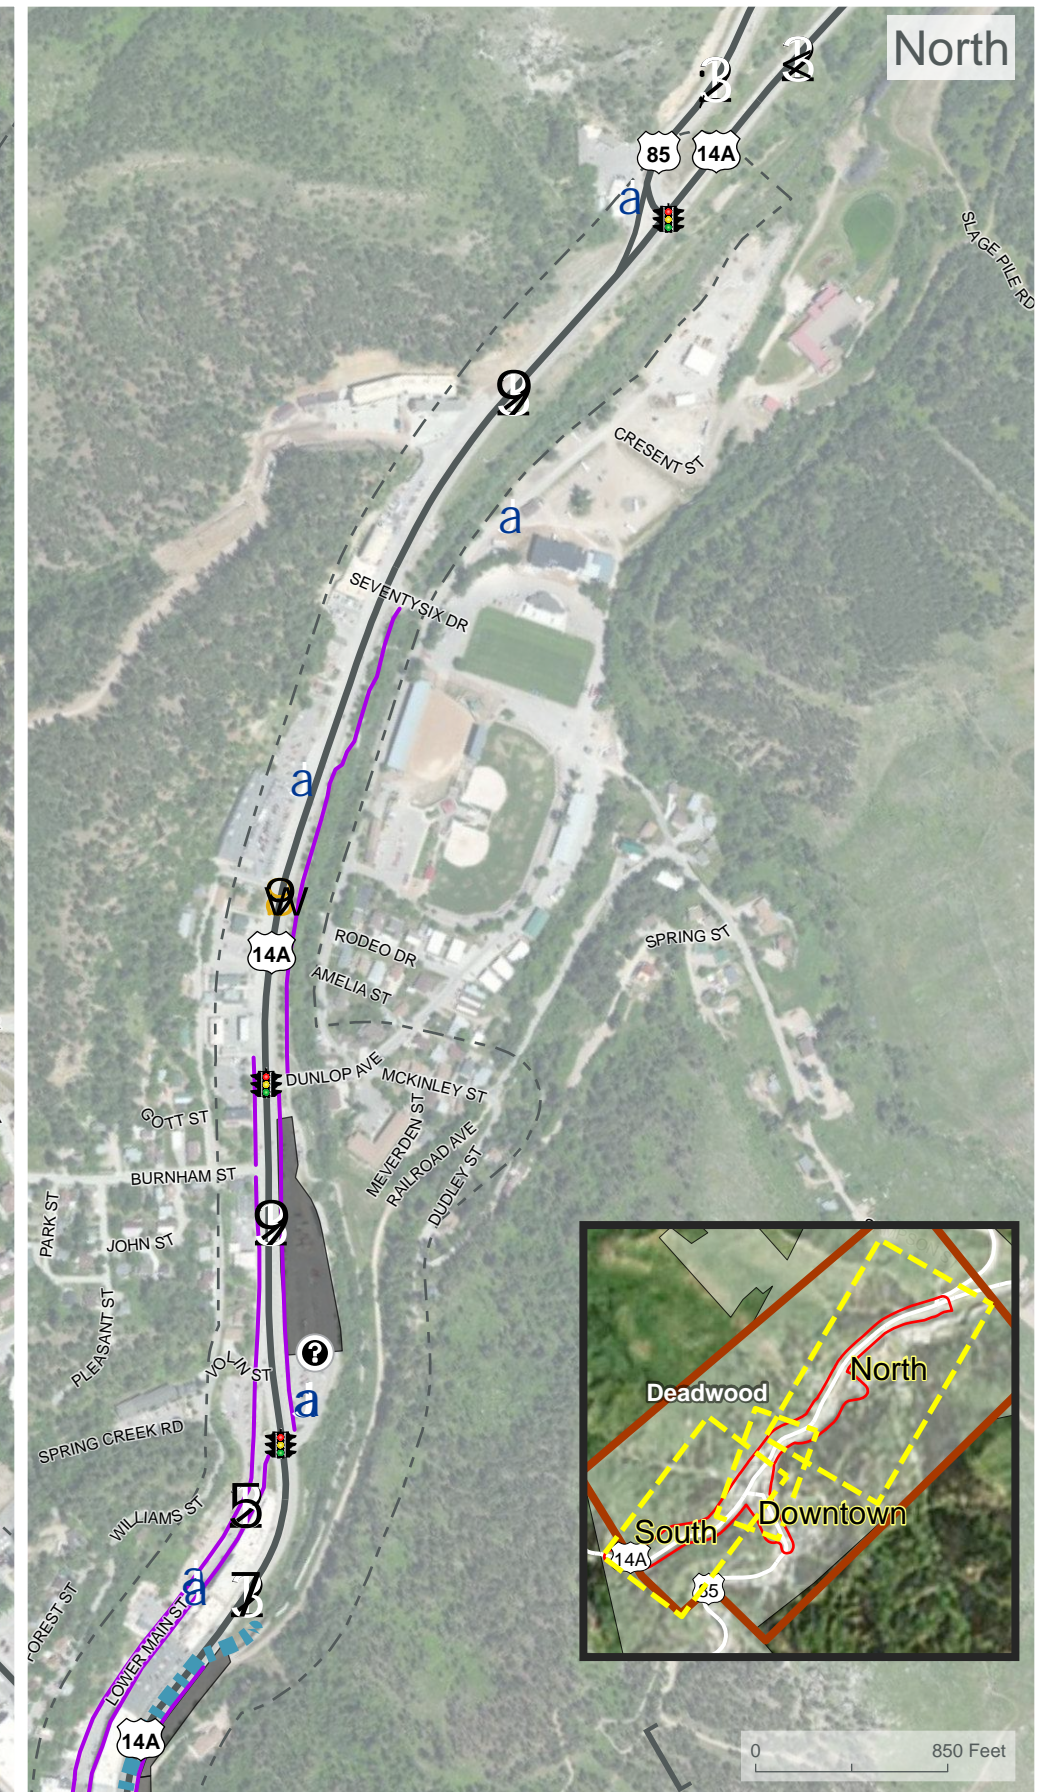
- Crosswalk with Rapid Flashing Beacon
- Signal
- Off-Street Parking
- Existing Structure Alignment
- Study Area
- Municipal Boundary
- Pedestrian Facility**
  - 6 ft or more Sidewalk
  - Less than 6 ft Sidewalk
  - George S. Mickelson Trail
  - Homestake Trail
  - Whitewood Creek Trail
  - Future Whitewood Creek Trail
- Local Points of Interest**
  - Cemetery
  - Fire Department
  - Government
  - Park
  - School
  - Tourism
  - Outlaw Square
  - Rec Center

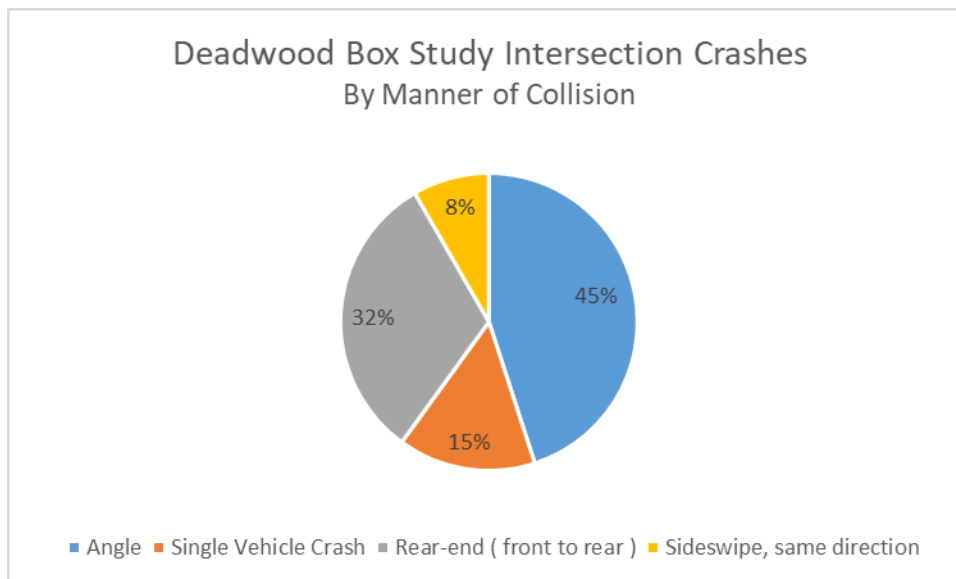
**Figure 28. Deadwood Box Study Intersection Crashes by Manner of Collision (2015 – 2019)**

There were a total of 61 intersection crashes within the study area during the five-year period of 2015 to 2019. Figure 28 provides a summary of intersection crashes by crash type.

Angle collisions were the most prevalent type of crash reported, making up 45% of all intersection crashes. The intersection that experienced the highest number of angle crashes was Intersection 5 (US14A & Deadwood St), totaling five angle crashes. Intersection 7 (US 14A & Sherman St) experienced the highest number of rear-end collisions, with 6 (32%) crashes taking place there of the 19 total intersection rear-end crashes. There were 4 (44%) single-vehicle crashes that took place at Intersection 14 (US 14A & US85), out of the total 9 single-vehicle crashes reported at intersections.

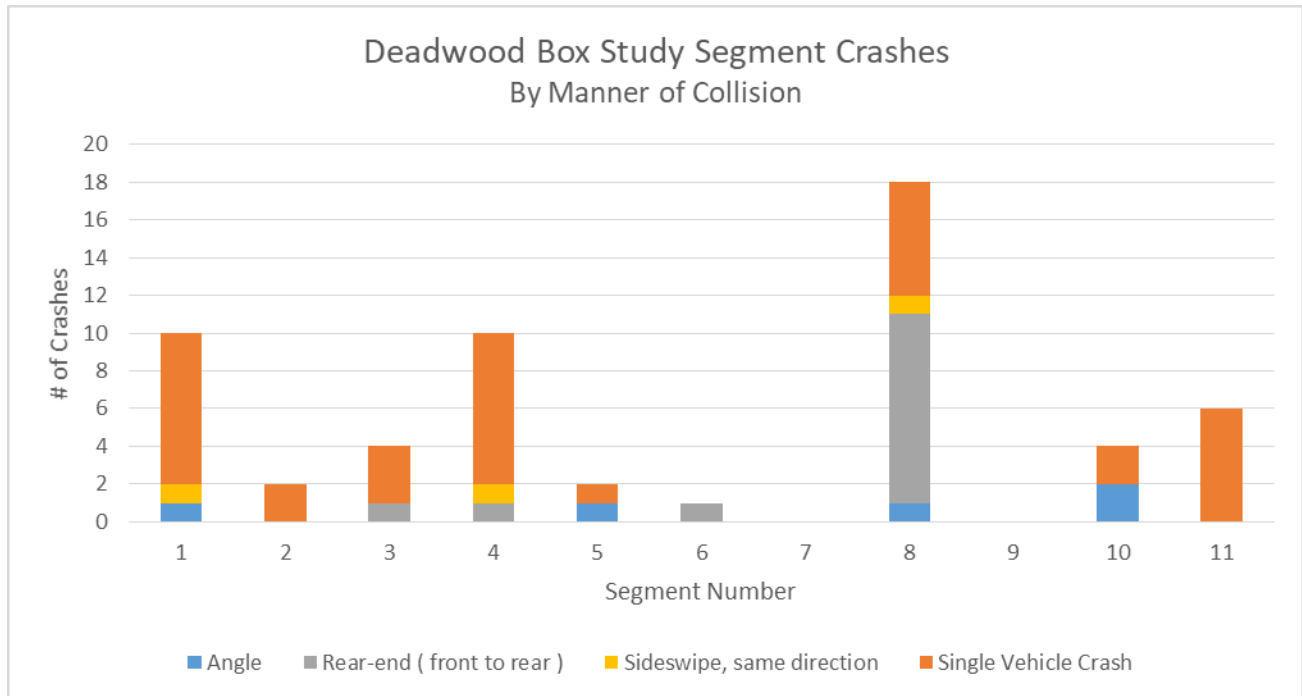
**Figure 29. Deadwood Box Study Segment Crashes by Manner of Collision (2015 – 2019)**

There were a total of 57 reported segment crashes in the study area over the five-year period. A breakdown of each intersection crash history by manner of collision is provided in Figure 29.

Segment 8 (US14A between Dunlop Avenue and US 85) experienced the most crashes at 18 total crashes. Ten (56%) of those 18 crashes were rear-end collisions, the most of any other segment. Segment 8 also experienced the most severe crash, an incapacitating crash that resulted in a single vehicle running off the road to hit a fixed object.
